Metro

**SUBJECT: Report on System Safety, Security and Operations.**

# Gold Line Service Disruption

September 28, 2015, 5:15 p.m.

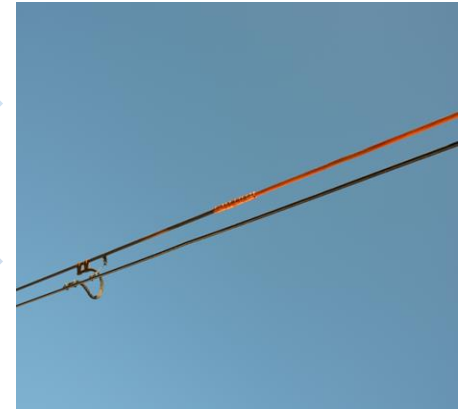
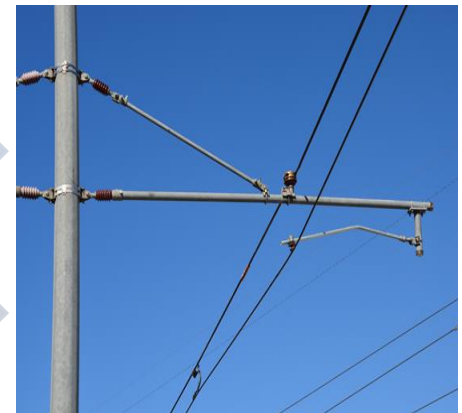
Ineffective/inefficient OCS inspection and repair equipment

Review and update Overhead Catenary System (OCS) inspection frequency and contact wire stagger
