**Board Report**

SUBJECT: METRO PUBLIC ART STATE OF GOOD REPAIR REPORT AND PHASED APPROACH TO ART ASSET MANAGEMENT

Attachment B - Metro Public Art Collection Asset Condition Report

Attachment C - Examples of Artwork in Need of Repair or Refurbishment

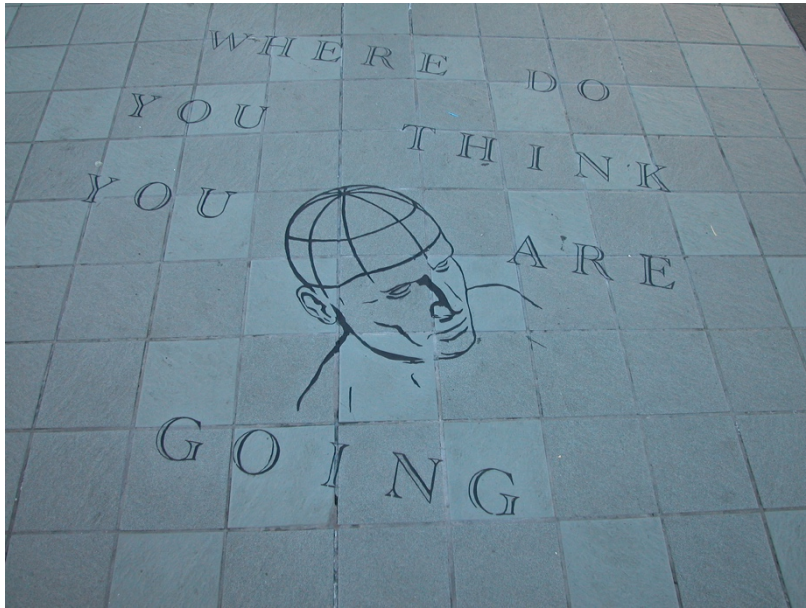
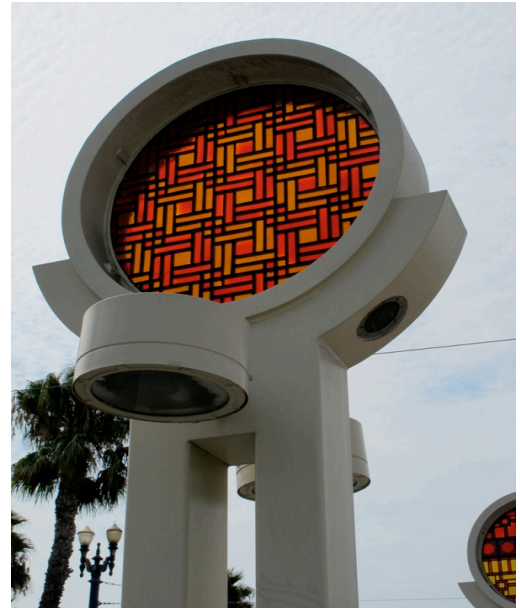
Metro Blue Line – Artworks impacted as part of Blue Line Refurbishment Project, require renovation

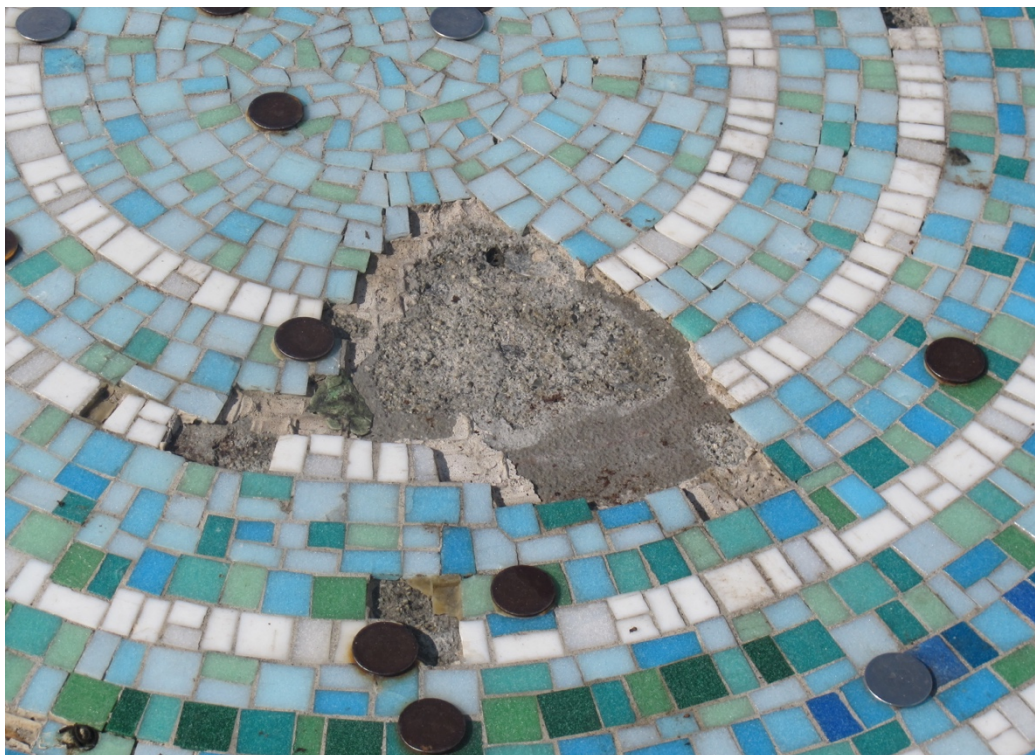
Metro Blue Line – Damaged artwork mosaic tile requires specialized repairs

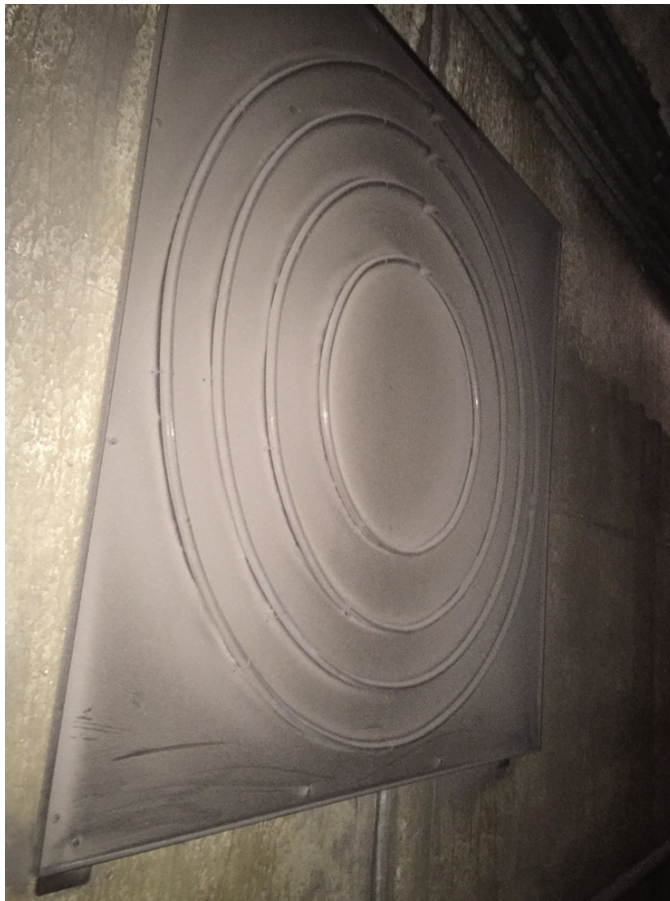
Metro Blue/Expo Tunnel – Outdated electrical artworks not functioning as intended

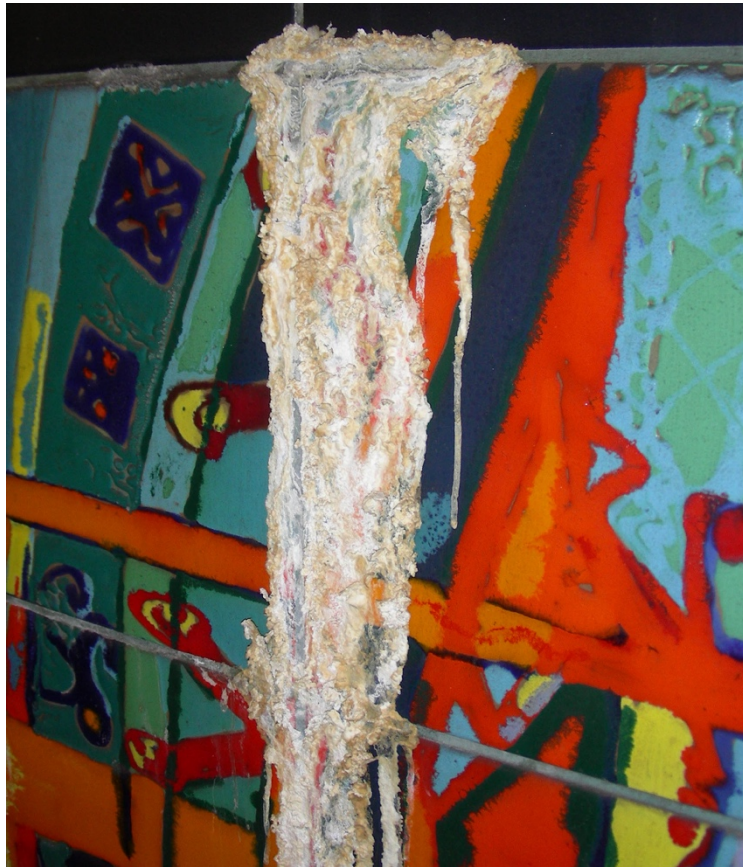
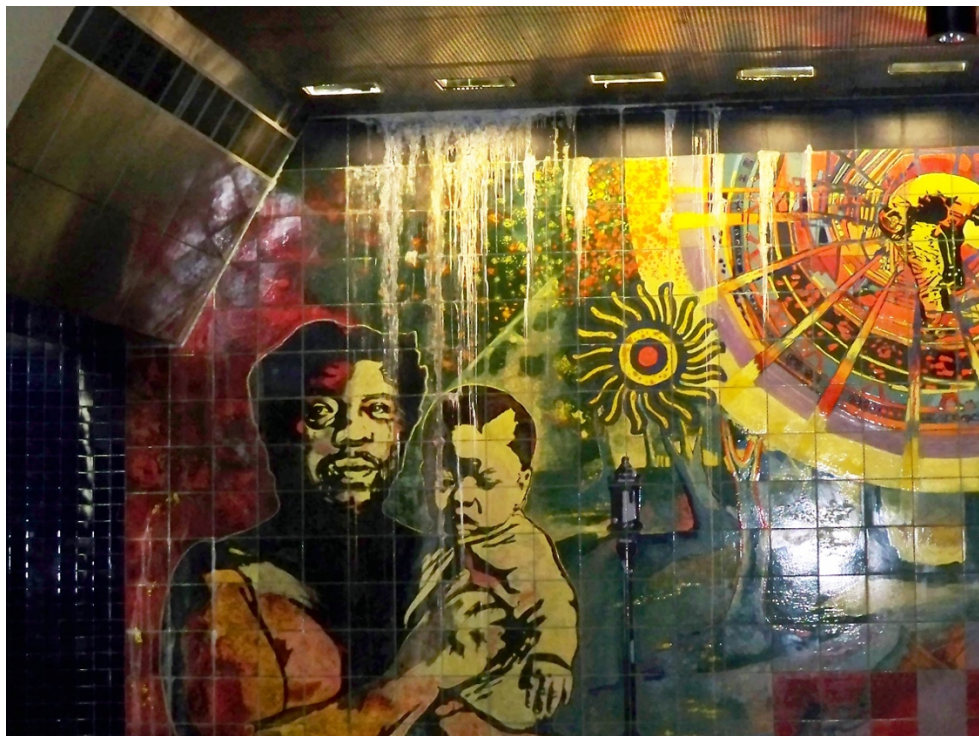
Metro Red Line – Artworks require specialized repair

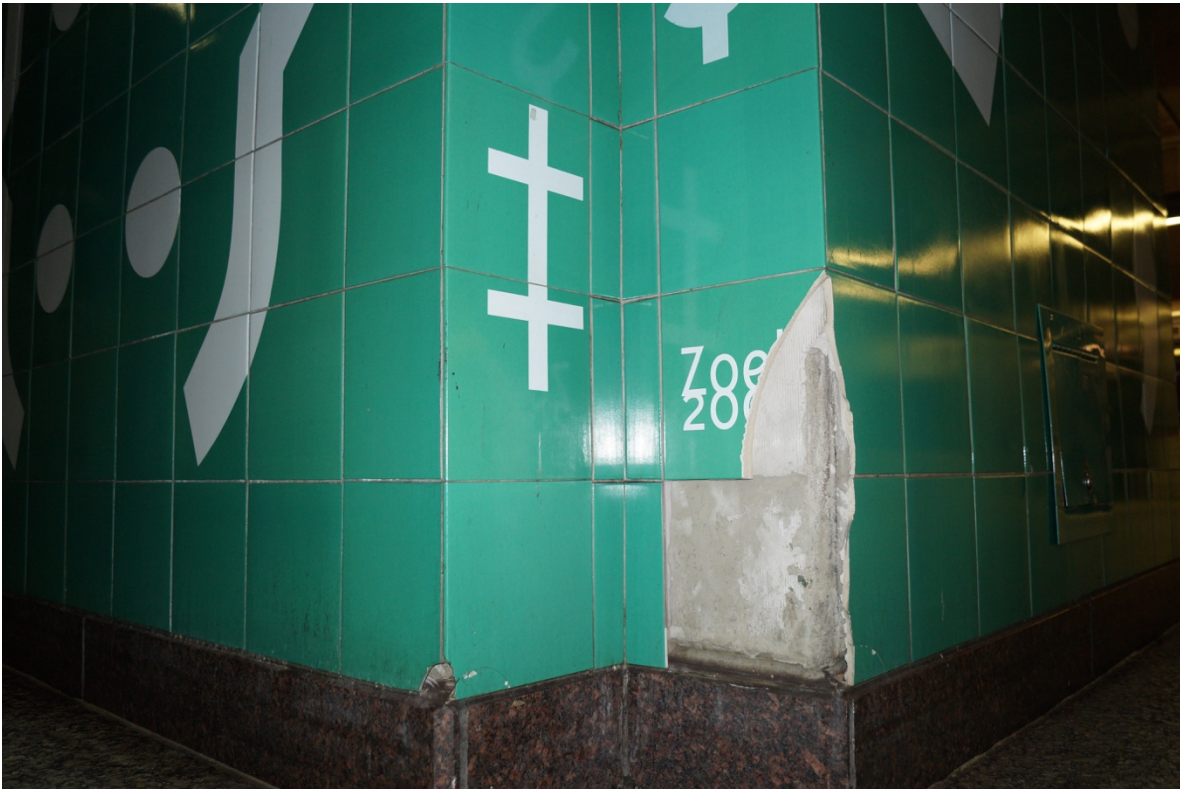
Metro Red Line – Damaged artwork tile requires specialized repairs

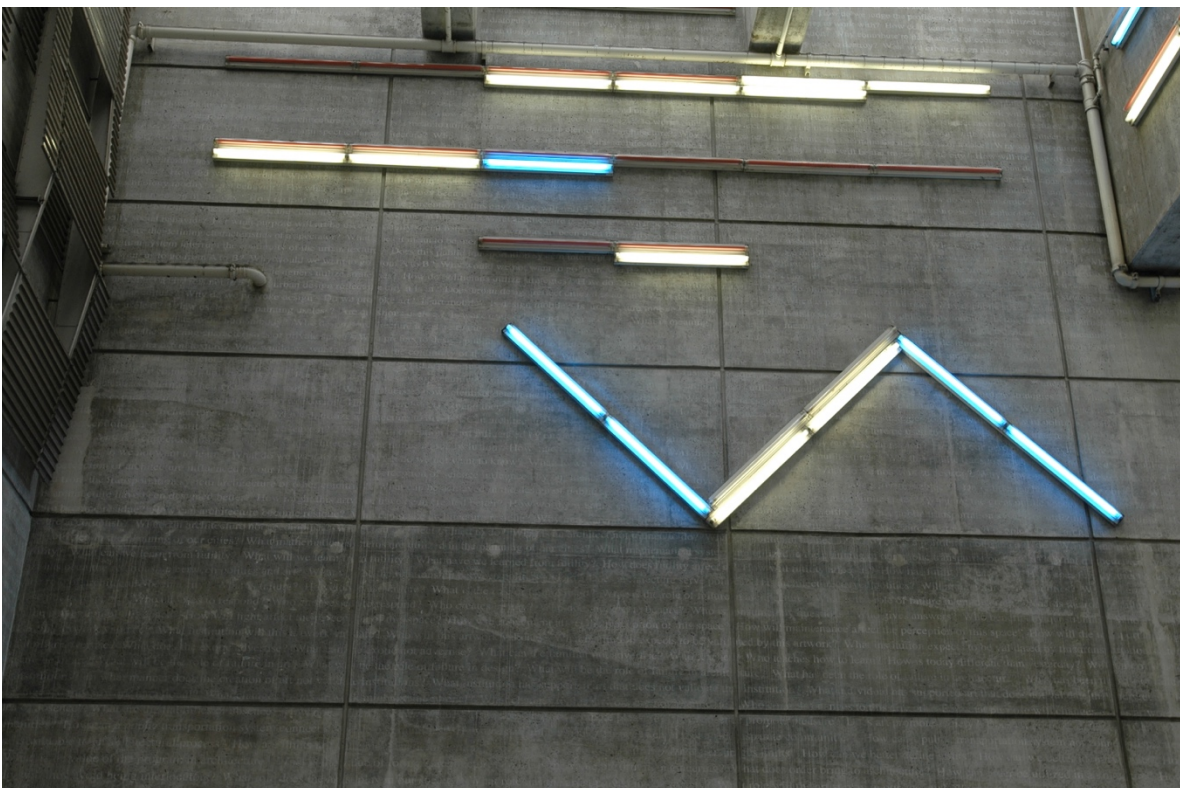
Metro Red Line – Outdated electrical artworks require renovation

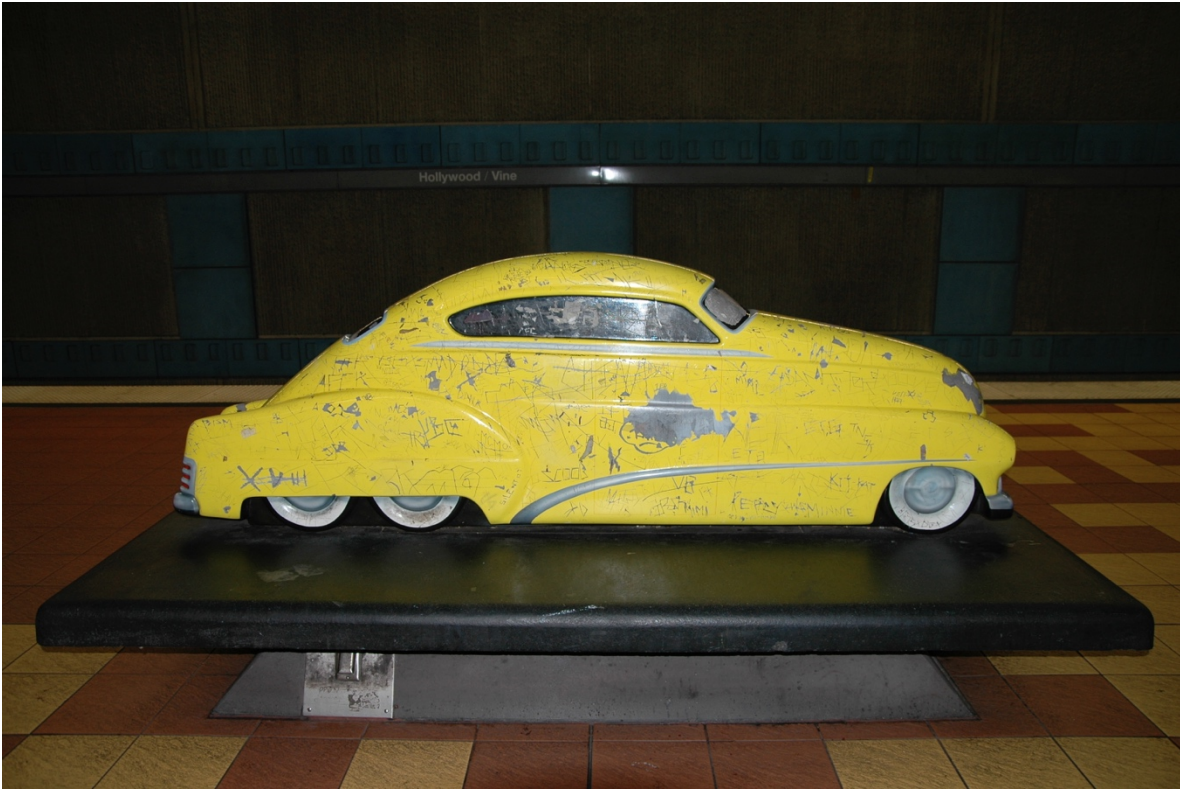
Metro Red Line – Artworks require renovation and relocation

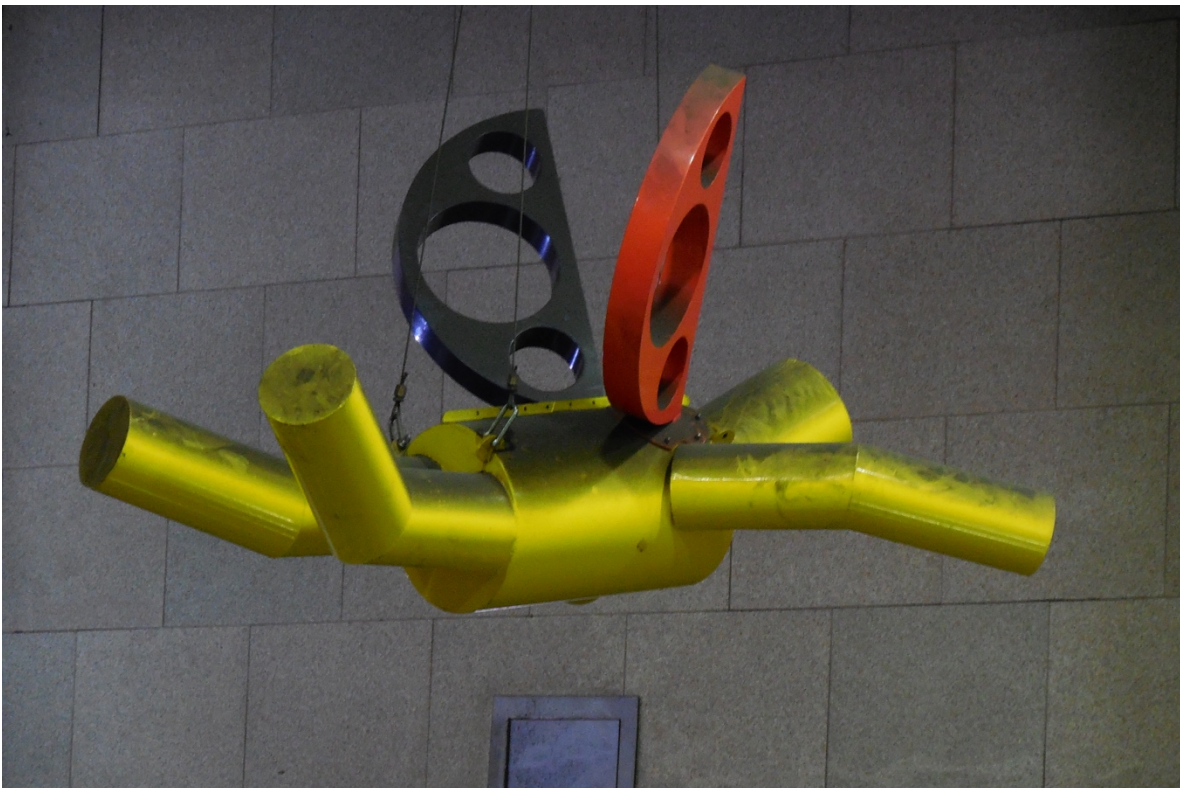
Metro Red Line – Artworks require specialized cleaning
