**Board Report**

**SYSTEM SAFETY, SECURITY AND OPERATIONS COMMITTEE
AD HOC CUSTOMER EXPERIENCE COMMITTEE
NOVEMBER 16, 2017****SUBJECT: OFFICE OF THE INSPECTOR GENERAL REPORT
ON REVIEW OF METRO RAIL SERVICE DISRUPTIONS****ACTION: RECEIVE AND FILE****RECOMMENDATION**

Review of Metro Rail Service Disruptions

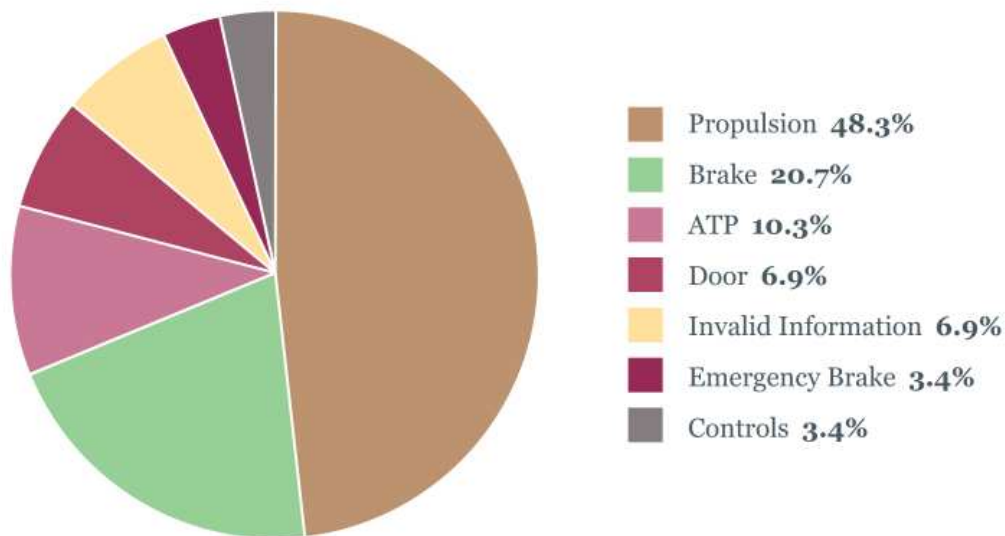
Figure 11: No Issues Identifiable (P2000)

- The chart above shows that 48.3% of no issue identifiable incidents were reported as propulsion issues. This indicates that the propulsion system diagnostics are more complicated than on the P865 and P2550 cars.
- The average maximum delay of these incidents was: 9.6 minutes per car.

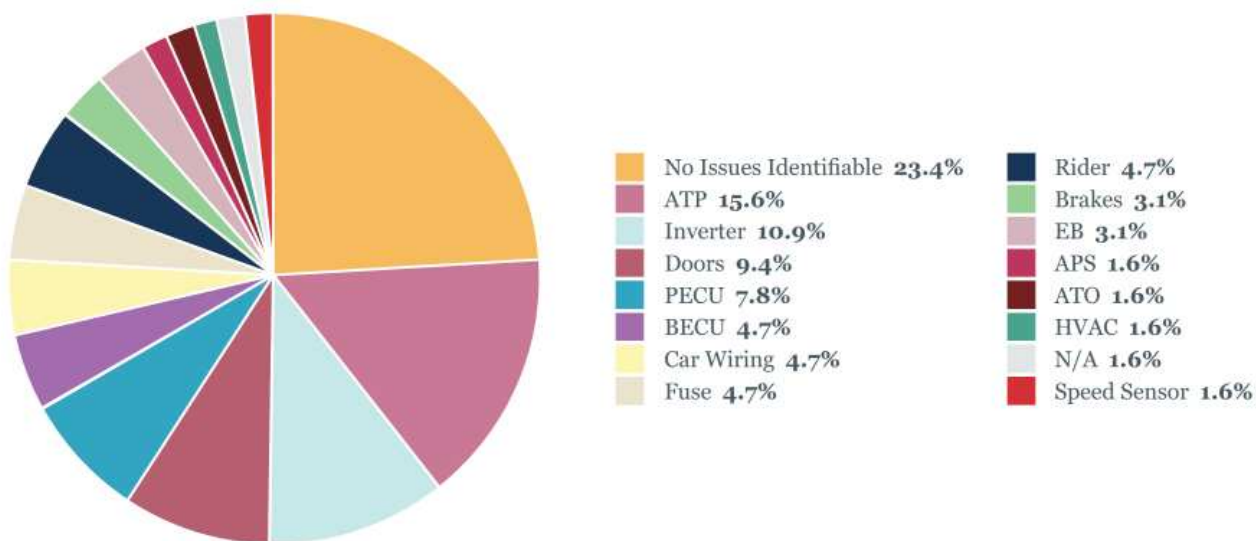
Figure 17: Causes of Rail Vehicle Incidents - Subway (GE)

C47. 18.7% of the incidents were caused by the propulsion system, mainly the inverter modules and the controls PECU. The average maximum delay was 9.25 minutes per incident.

C48. 15.6% of incidents were due to equipment failures of the ATO/ATP system. The average maximum delay was 9.6 minutes per incident.
