**SUBJECT: NEW BLUE/ EXPO SERVICE AND PROJECT MANAGEMENT**

# **New Blue/Expo Service & Project Update**

# Metro Gold Line Overhead Catenary System

# Gold Line Incident 1 – Monday, September 9, 2019

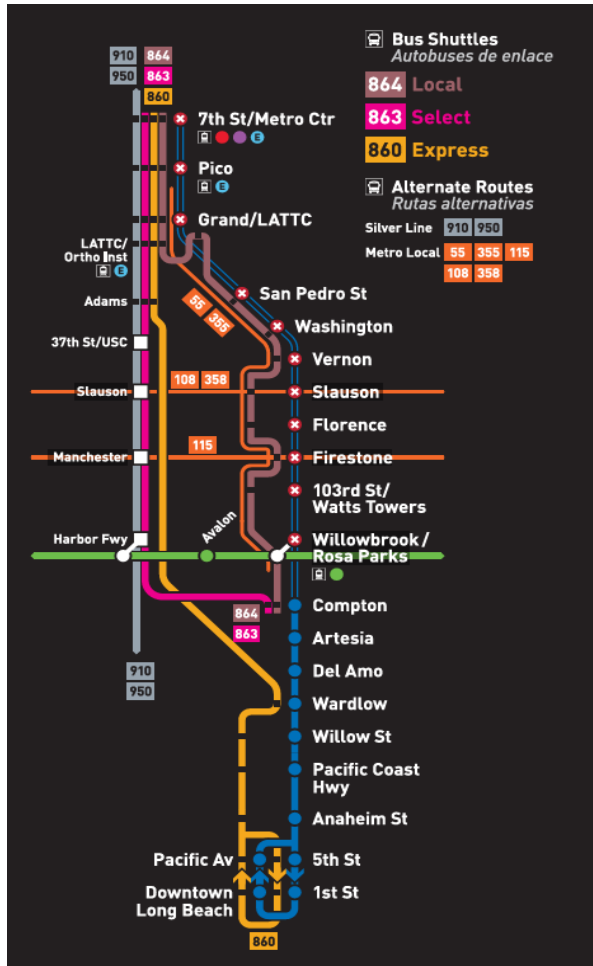
## Blue Line Bus Shuttle Service Ridership (June –July 2019)

### Frequency (Peak Period)

- Line 860 Express: 6-12 minutes
- Line 863 Select: 12 minutes/M-F
- Line 864 Local: 6-12 minutes

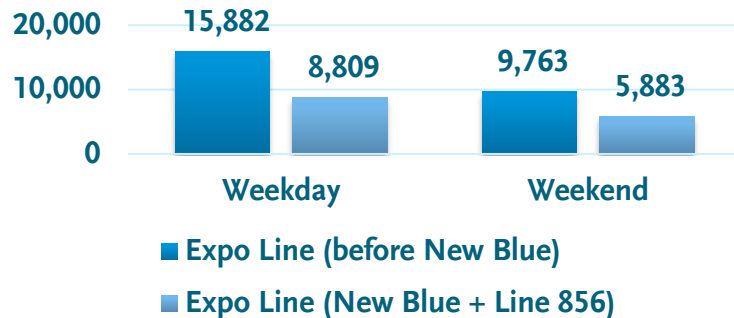
### Expo Bus Shuttle Comparative Ridership

Average Ridership	Weekday	Weekend
Expo Line 856 - June 2019	15,882	9,763
Expo Line 856 - July 2019	8,809	5,883

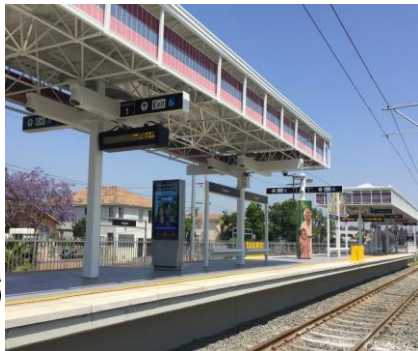
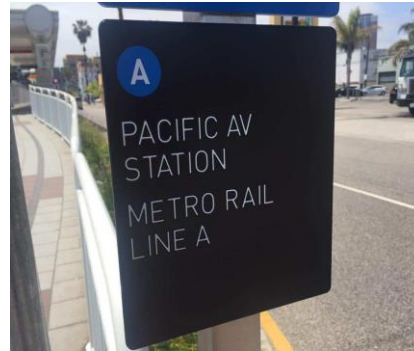
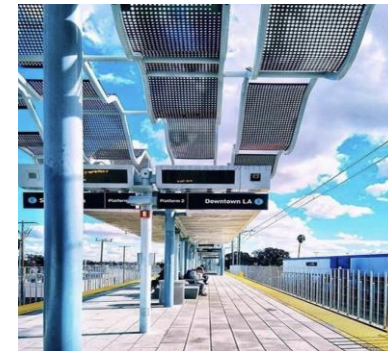
- Status: Completed (Saturday, January 26, 2019 – Friday, May 31, 2019)
- **Project Highlights:**
- Initiated Willowbrook/Rosa Parks platform and building renovation work on Day 1
- Completed brand new Compton interlocking
- Long Beach Loop signal upgrades, landscaping and fence work
- All new street running trackwork in Long Beach
- New fall protection on bridge segments
- New overhead contact system (OCS)
- Network upgrades for camera and digital map cases
- Station painting and tile renewal work
- New digital map cases and station signage

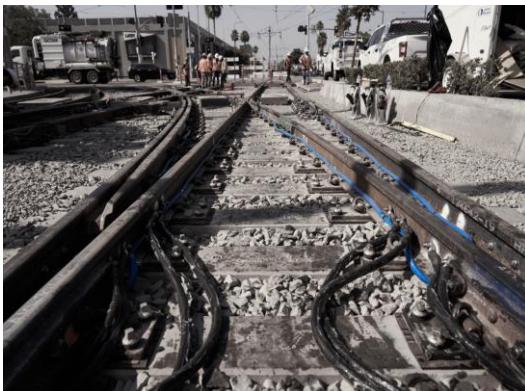
Expo Junction Trackwork

- Status: Completed (Saturday, June 22, 2019 – Friday, August 23, 2019)
- **Project Highlights:**
- New overhead contact rail (OCR) system (first ever at Metro)
- New #10 interlocking and track fasteners in Flower tunnel
- Rebuilt a portion of the Washington Junction and special trackwork
- Pico Station painting, tile renewal, digital map cases, and new signage
- All work completed around the clock within 60 day allocated closure window.

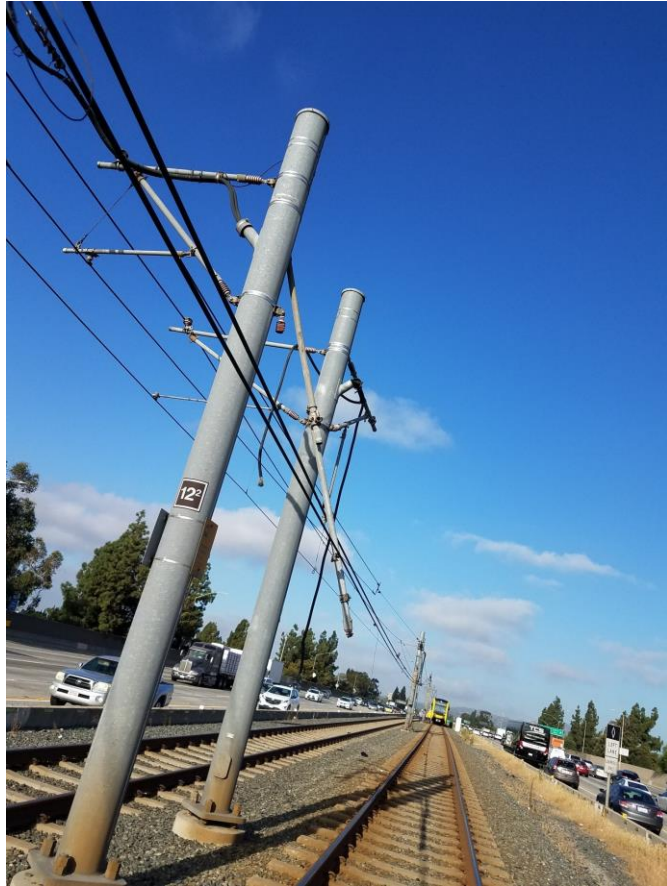
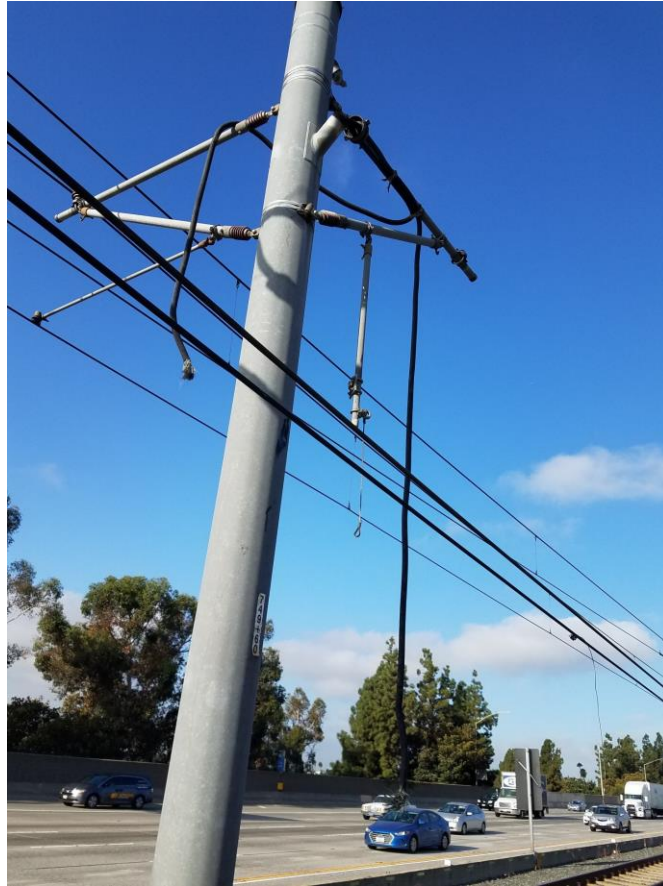
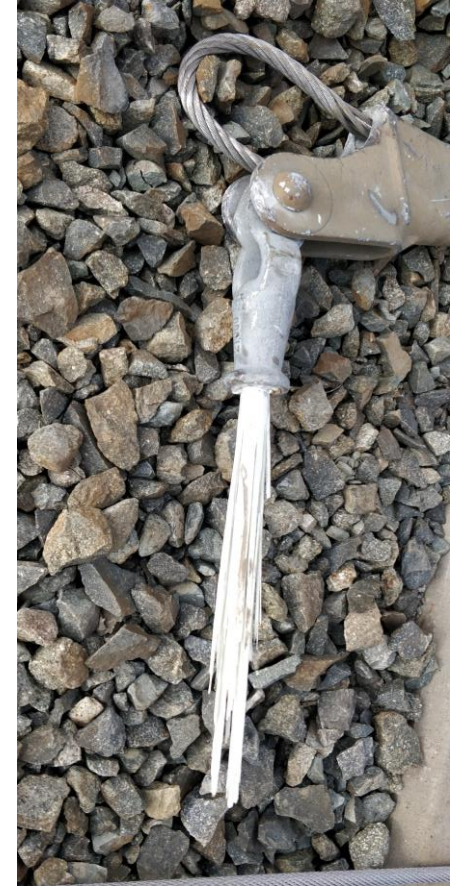
# Gold Line Incident 1 – OCS Damage

- A dog bone insulator broke at a balance weight assembly, causing the OCS wire to sag far below normal operating height
- As a vehicle traveled on track 2, it collided with the OCS wire, damaging OCS assemblies and 1500 feet of messenger/contact wire

Safety tether installation

- ✓ Two crews with 10 Inspectors and a Supervisor worked to repair damage
- ✓ OCS cantilever arms were reconnected to OCS poles
- ✓ Replacement of the dog bone fiberglass insulator rod
- ✓ Raising of the messenger and contact wire
- ✓ Reconnection of the wire assembly to the weight stack (safety tether)

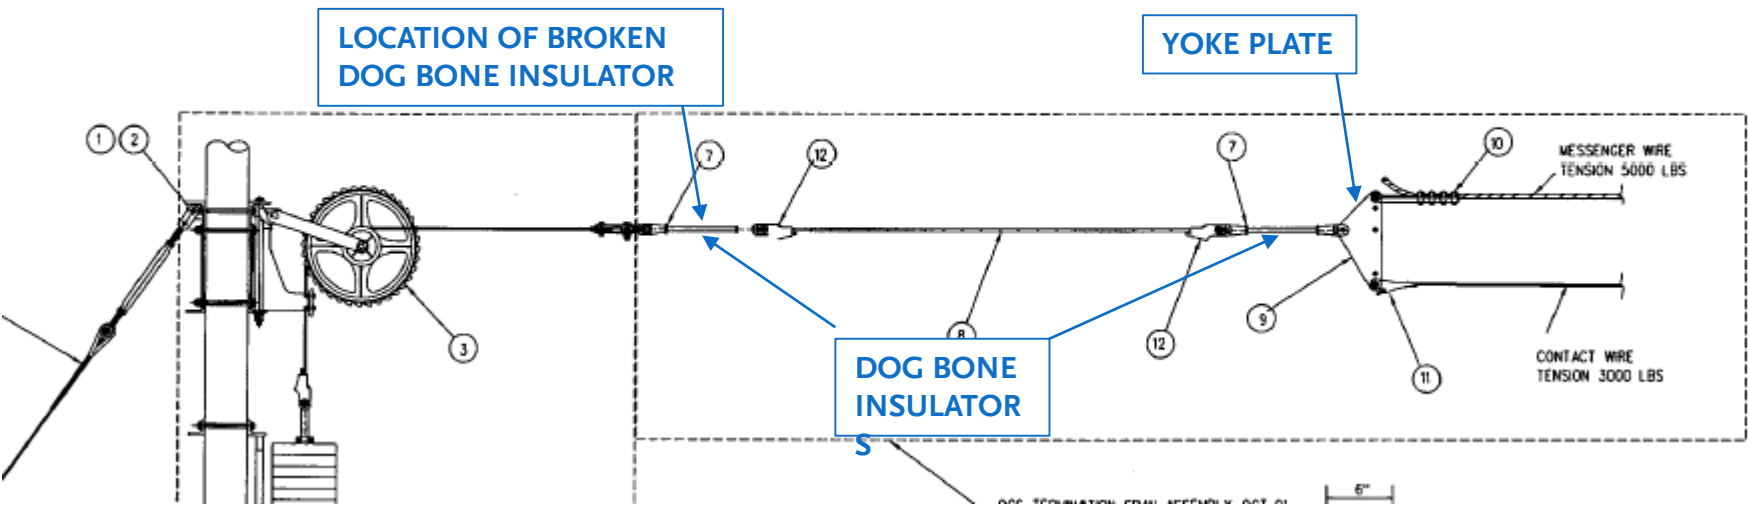
DETAIL DRAWING OF ASSEMBLY

# Incident Assembly Configuration – Gold Line Pasadena Section

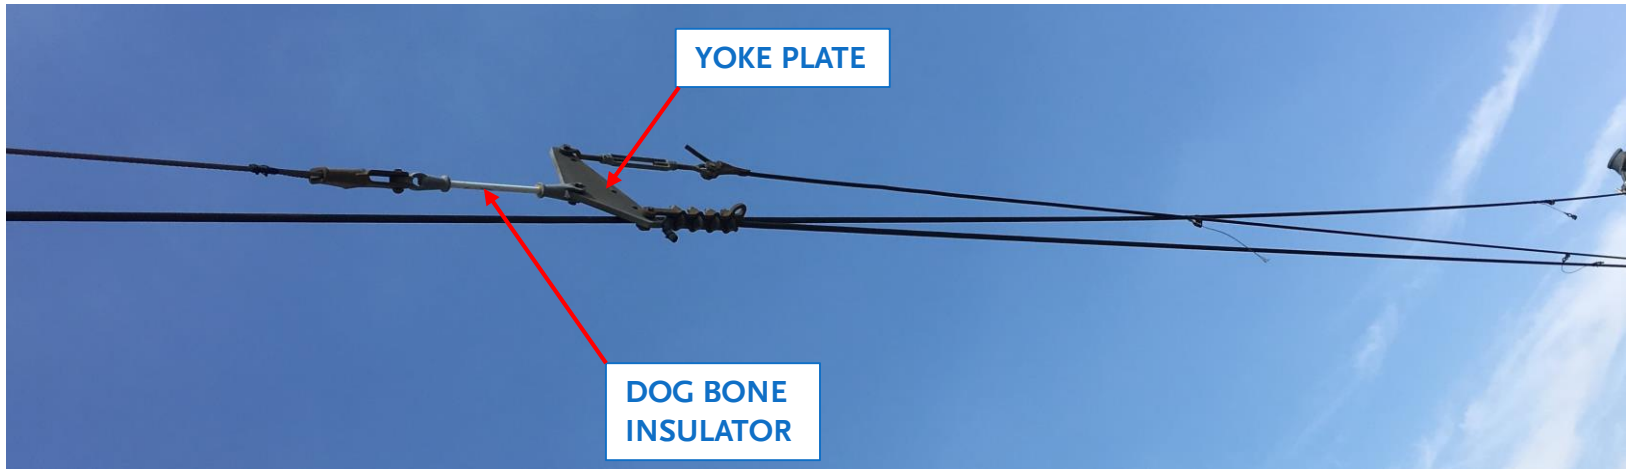
DETAIL DRAWING OF BALANCE WEIGHT ASSEMBLY

A dog bone insulator broke at a balance weight assembly, causing the OCS wire to sag below normal heights. As a vehicle traveled on track 1, it's pantograph snagged on the wire, damaging the OCS supports and assemblies.

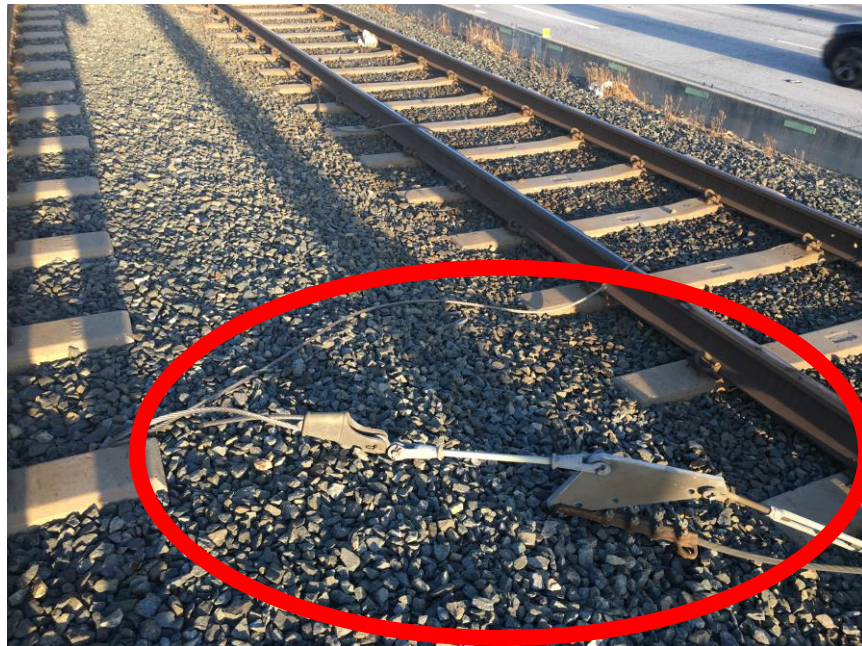
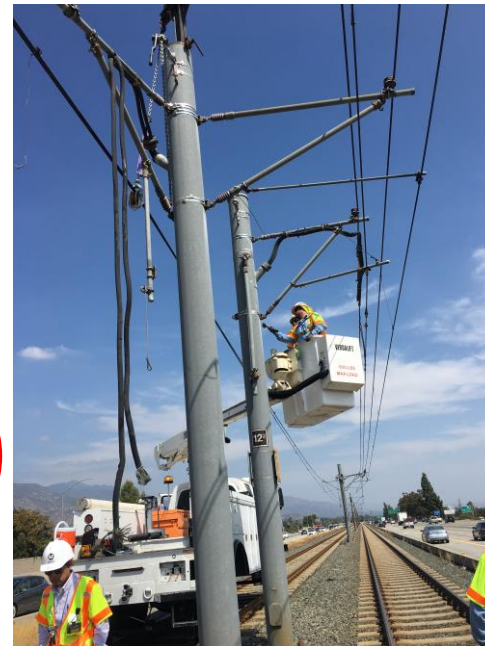
Locations with Existing Safety Tethers: Blue Line, Green Line, Gold Line Eastside & Foothill Extensions, Expo Line, and Crenshaw Line

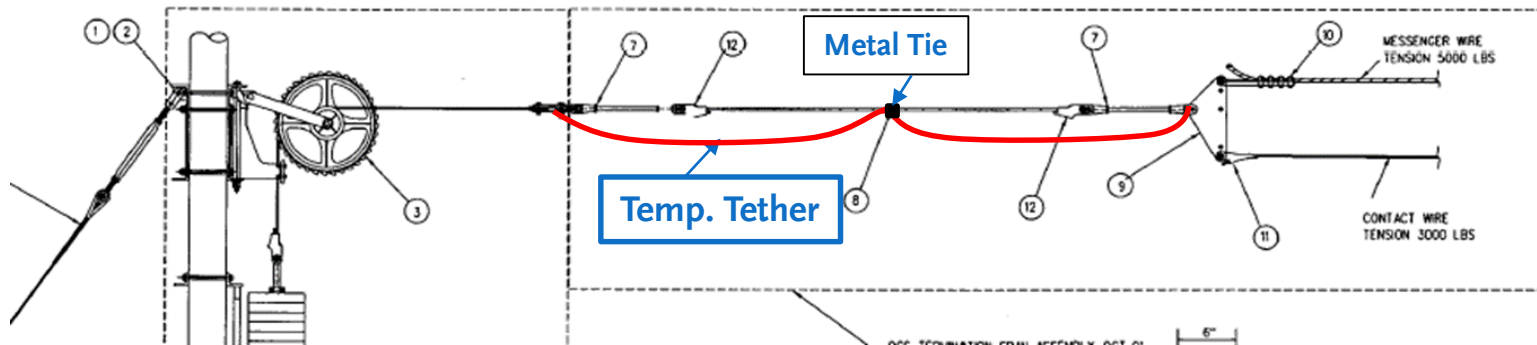
- Install temporary safety tethers on all termination assemblies along the Gold Line Pasadena (Union Station to Sierra Madre Station)
  - Rate: 5 per day/3 days per week
  - Timeline: December 2019
- Impound all spare dog bone insulator parts
- Lab test defective dog bone insulator
- Purchase improved dog bones

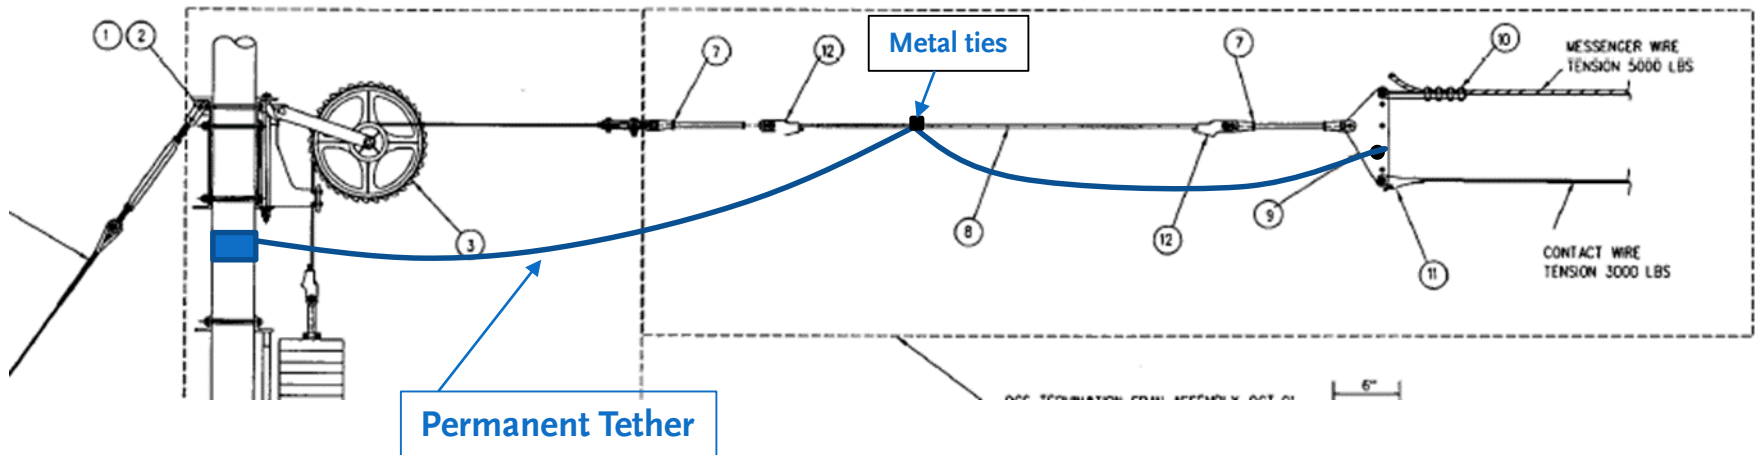
- Improve quality management of spare part inspection and verification process
- Install permanent safety tethers to retrofit the Gold Line Pasadena (Union Station to Sierra Madre Station)
- Timeline: Mid - 2020
