**Board Report**

**SYSTEM SAFETY, SECURITY AND OPERATIONS COMMITTEE
AD HOC CUSTOMER EXPERIENCE COMMITTEE
NOVEMBER 16, 2017****SUBJECT: OFFICE OF THE INSPECTOR GENERAL REPORT
ON REVIEW OF METRO RAIL SERVICE DISRUPTIONS****ACTION: RECEIVE AND FILE****RECOMMENDATION**

Review of Metro Rail Service Disruptions

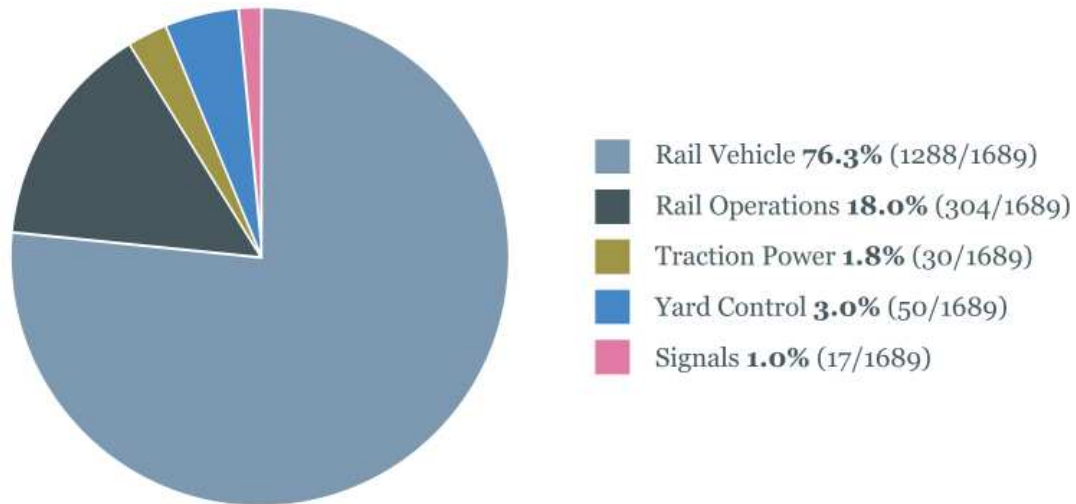
Figure 1: Distribution of Top Three Light Rail Incidents

B2. Rail vehicle incidents and rail operations incidents were the top two service delay incidents across each of the four light rail lines, accounting for nearly 95% of the 1,689 delay incidents (76.3% rail vehicle incidents and 18.0% rail operations incidents). See Figure 1.

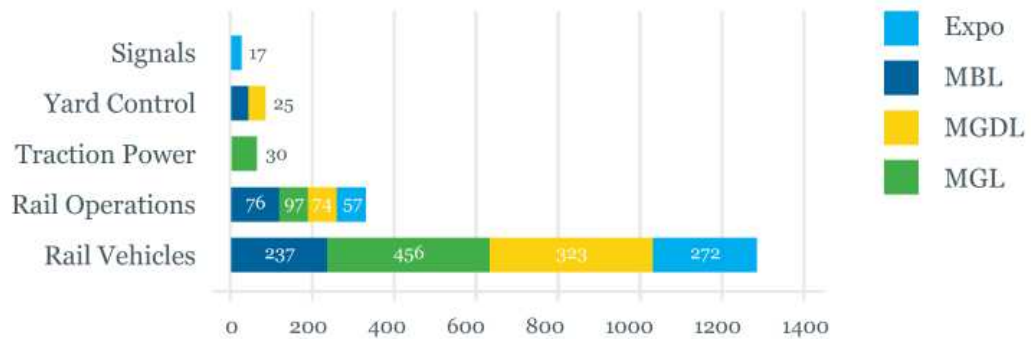
Figure 2: Distribution of Top Three Incidents on each Light Rail Line

B4. Of all the light rail lines, the MBL had the largest number of rail vehicle incidents and rail operations incidents. (see Figure 2 below.)

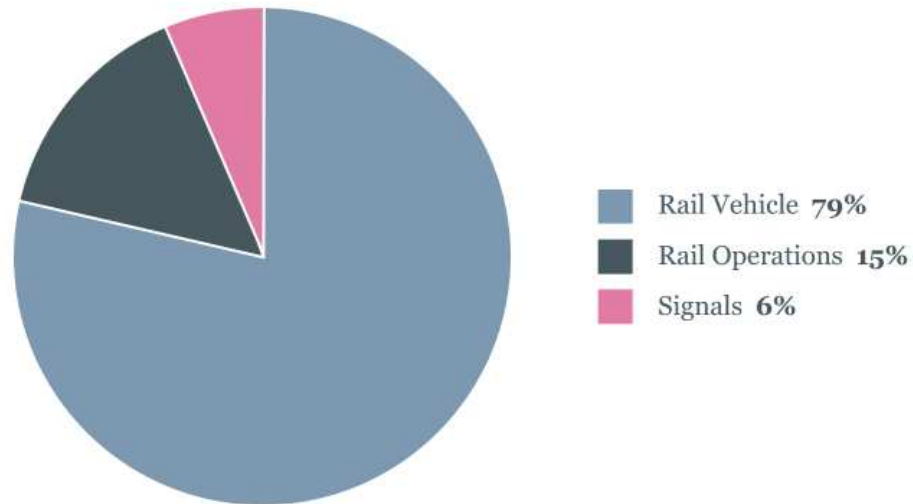
Figure 3: Distribution of Top Three Subway Incidents

B6. Rail vehicle delays comprised 79% of the top three causes, as shown in Figure 3:

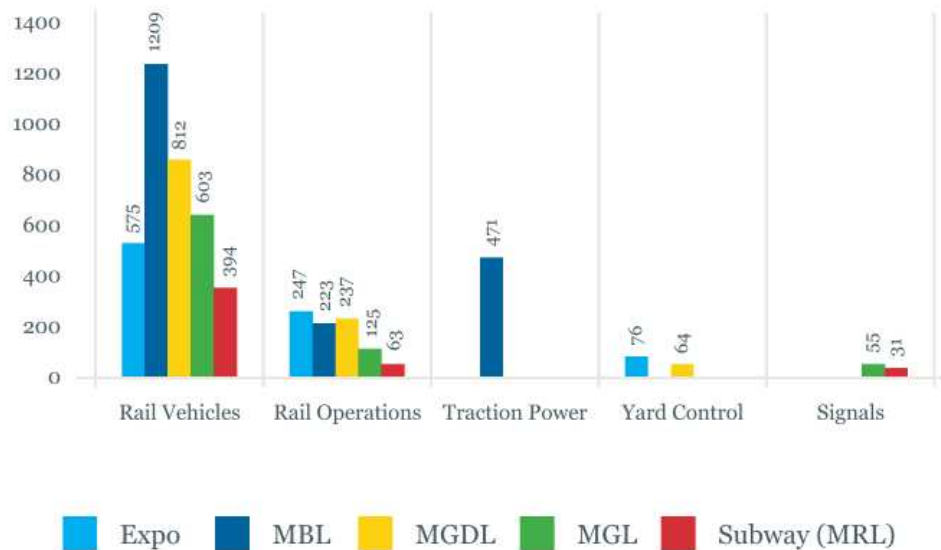
Figure 4: Total Cancelled and Late Trains by Top Three Incident Types

B7. Rail vehicle service delays and rail operation service delays were also the two causes of delay responsible for the largest total number of cancelled and late trains and the highest total of maximum delay minutes. (The ROC records the longest delay from amongst those trains delayed by an incident in the delay incident report as the maximum delay minutes for each incident.) See Figure 4.

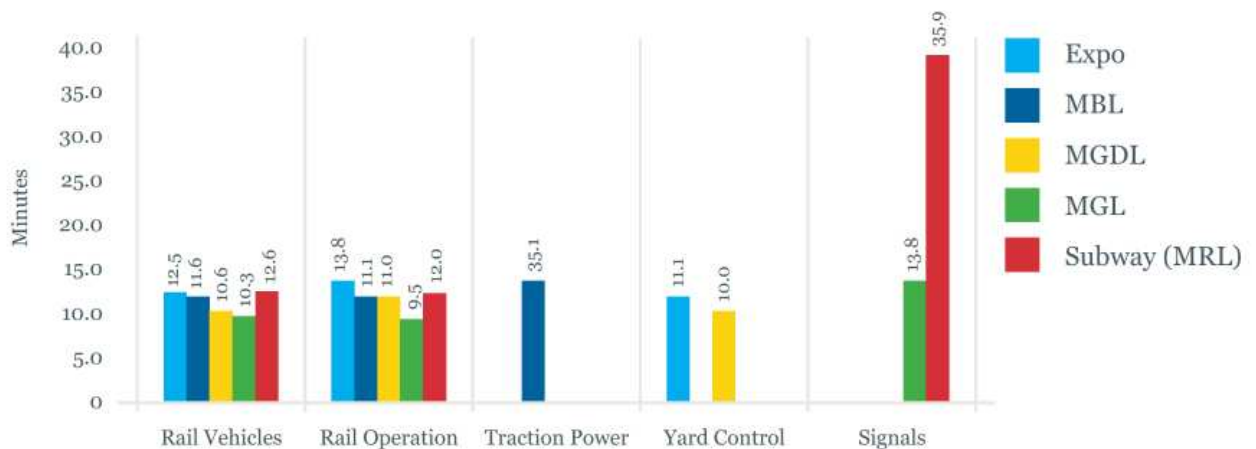
Figure 5: Average ‘Maximum Delay’ Minutes for Top Three Incidents Per Line

B10. The average maximum delay minutes were also highest for traction power and subway signal incidents. (see Figure 5.)

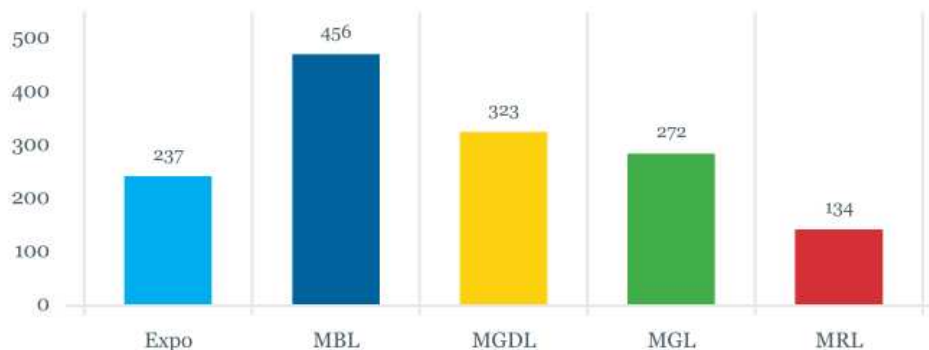
Figure 6: Rail Vehicle Incidents by Line

Based on the information from the ROC, a total of 1,422 rail vehicle incidents were recorded for 2016, 1,288 on the four light rail lines and 134 on the subway. (For subways, Metro Purple Line is incorporated into Metro Red Line for this report.) The MBL, which has the largest fleet, had the most rail vehicle incidents. (see figure 6.)

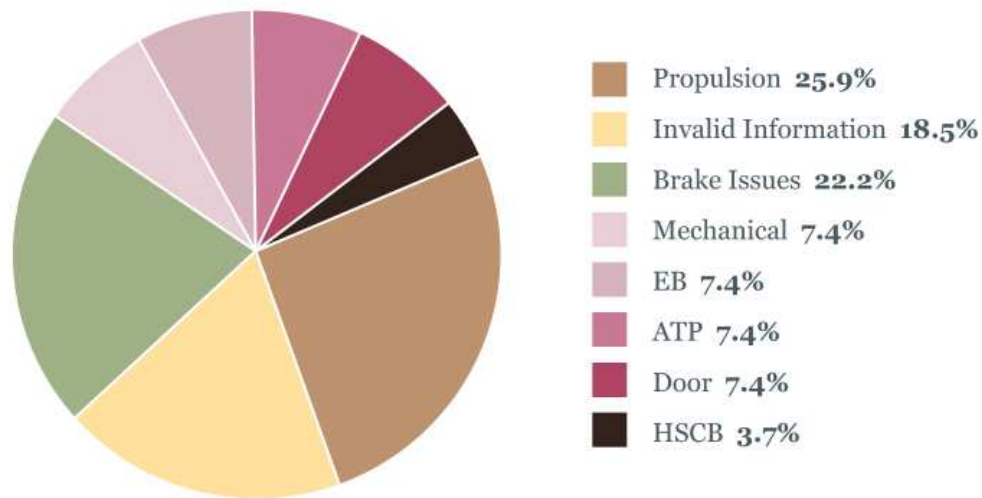
Figure 9: No Issues Identifiable (P865 & P2020)

- Figure 9 below classifies “No Issue Identifiable” incidents by the “Cause” of the delay as reported to the ROC.
- The average maximum delay of these “unidentifiable” incidents was 10.8 minutes.

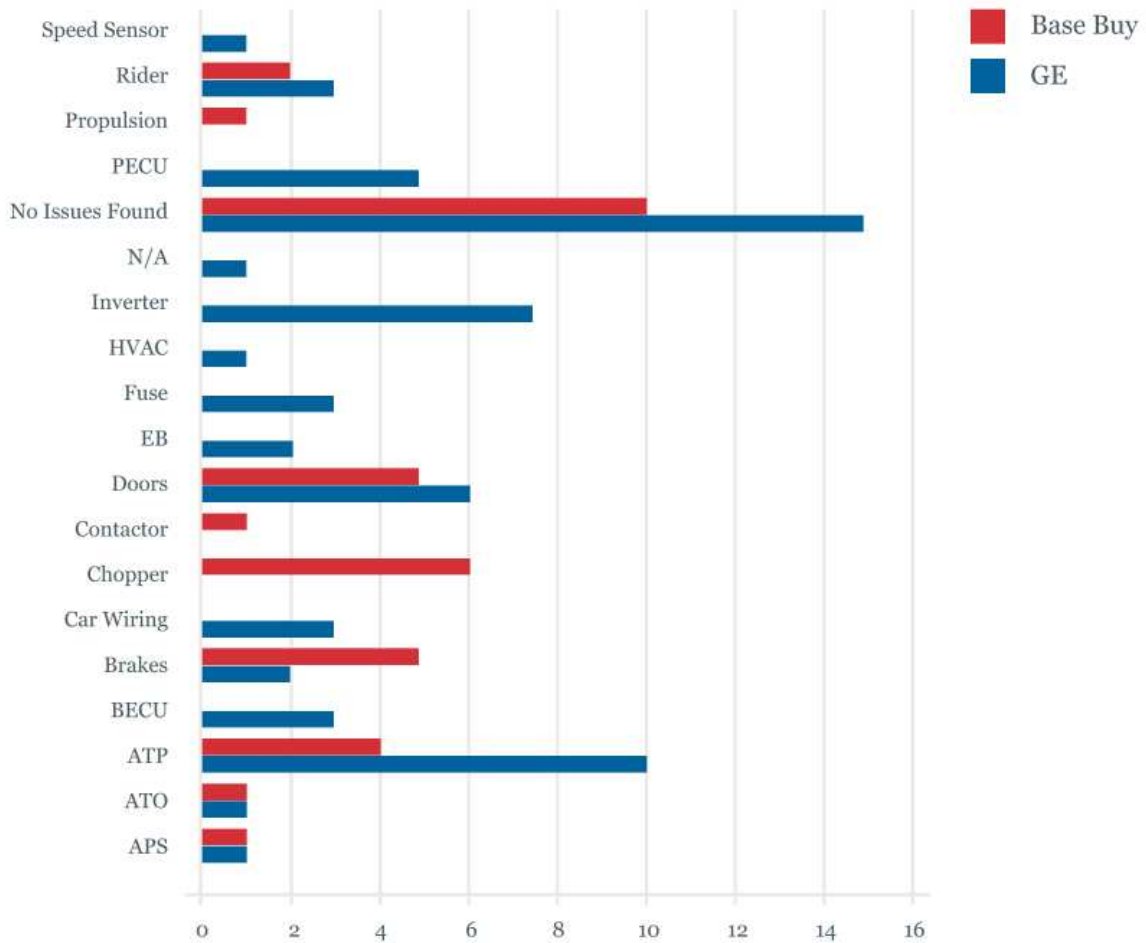
Figure 14: Causes of Rail Vehicle Incidents - Subway

The subway fleet consists of 30 Base Buy cars and 74 newer A650 General Electric (GE) cars. Review of sample incident reports for 2016 revealed that the Base Buy cars had a higher incident rate per vehicle than the GE cars. GE cars had more total incidents since they consist of 71% of the total subway fleet. Most of the vehicle components for the GE and Base Buy fleets are identical, other than the propulsion system and vehicle controls. Figure 14 below shows the number of rail vehicle incidents by causes.

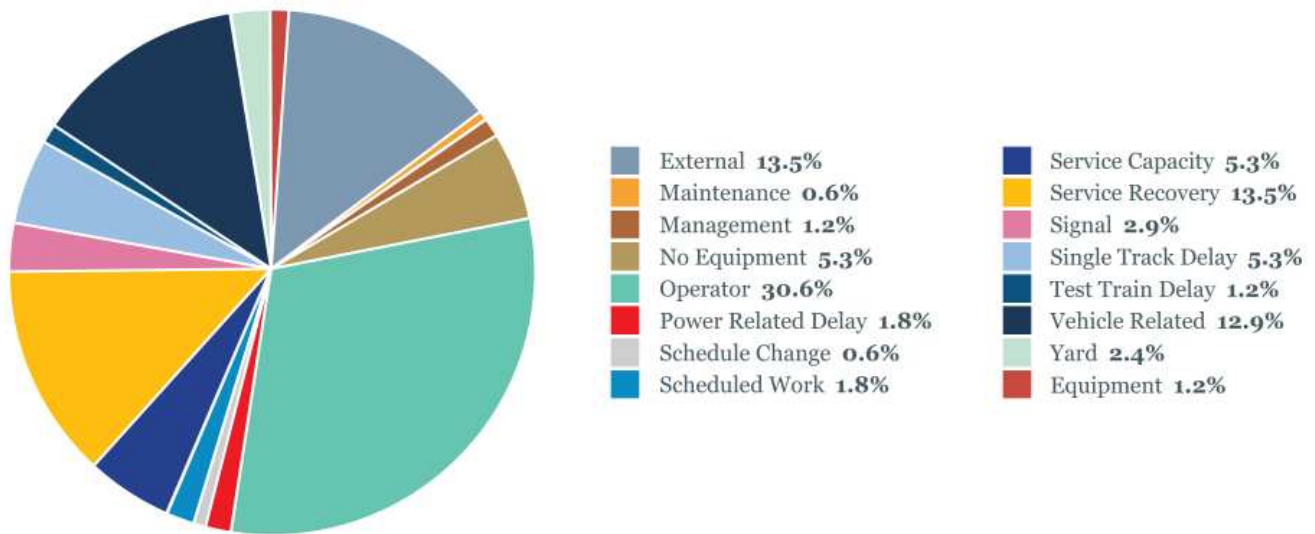
Figure 19: Causes of Rail Operations Incidents (Light Rail)

A sampling of 170 of the Light Rail Operations incidents were examined to further assess the types and related causes of incidents. These incidents were categorized into 16 primary causes of Light Rail Operations delay incidents. (see Figure 19.)

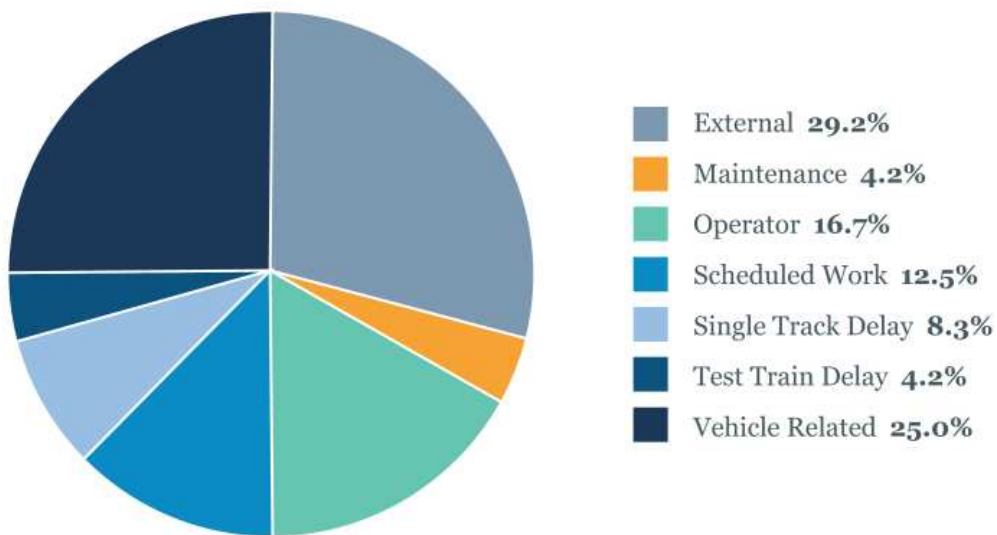
Figure 20: Causes of Rail Operations Incidents (Subway)

Similarly, the 26 delay incidents attributable to rail operations on the MRL were categorized into seven primary causes. (see Figure 20 below.)

D3. On the MRL, operator caused incidents accounted for 16.7% of the 26 Operator related incidents. (see Figure 20 above.)

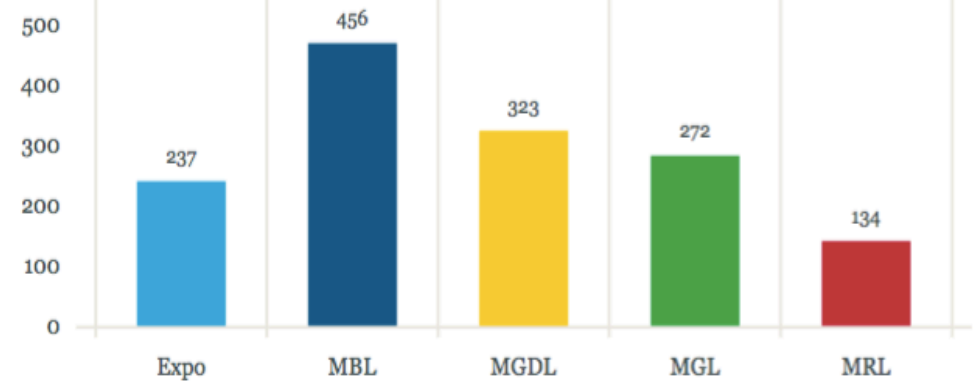
Rail Vehicle Incidents by Line

66% of total delays were rail vehicle – when you break that
down by subway and light rail it is still the #1 cause.

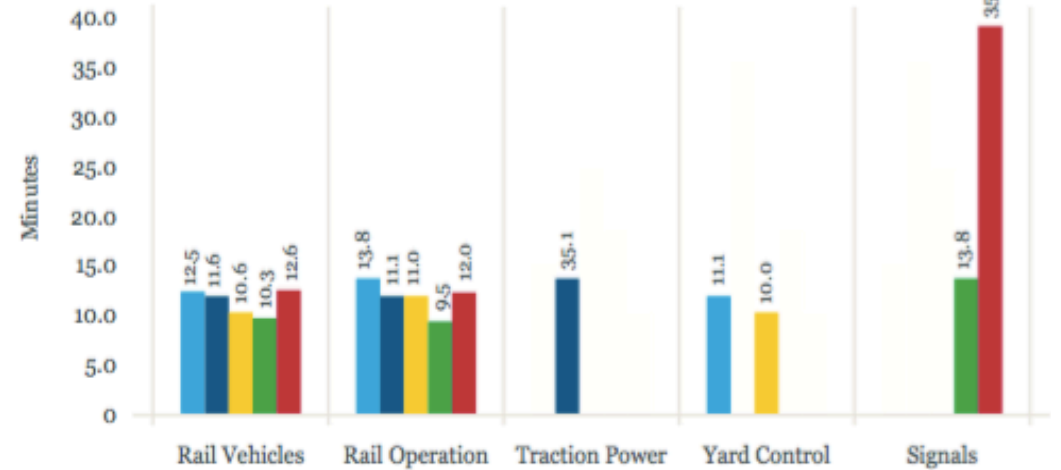
Average 'Maximum Delay' Minutes for Top 3 Incidents Per Line

*High average 'maximum delay' is from 10 signal incidents on the MRL
