**File #:** 2017-0606, **File Type:** Informational Report

**SUBJECT: OFFICE OF THE INSPECTOR GENERAL REPORT  
ON REVIEW OF METRO RAIL SERVICE DISRUPTIONS**

# Review of Metro Rail Service Disruptions

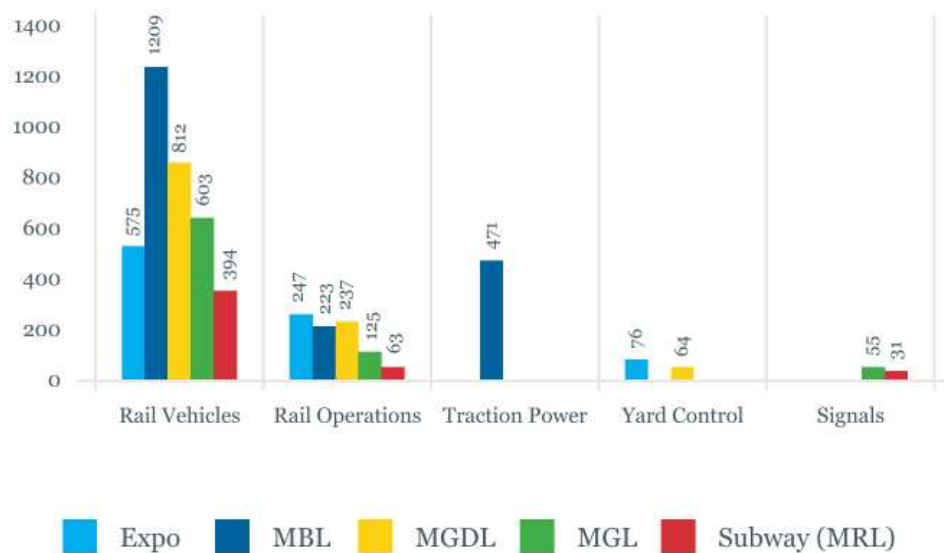
**Figure 4: Total Cancelled and Late Trains by Top Three Incident Types**

**B7.** Rail vehicle service delays and rail operation service delays were also the two causes of delay responsible for the largest total number of cancelled and late trains and the highest total of maximum delay minutes. (The ROC records the longest delay from amongst those trains delayed by an incident in the delay incident report as the maximum delay minutes for each incident.) See Figure 4.

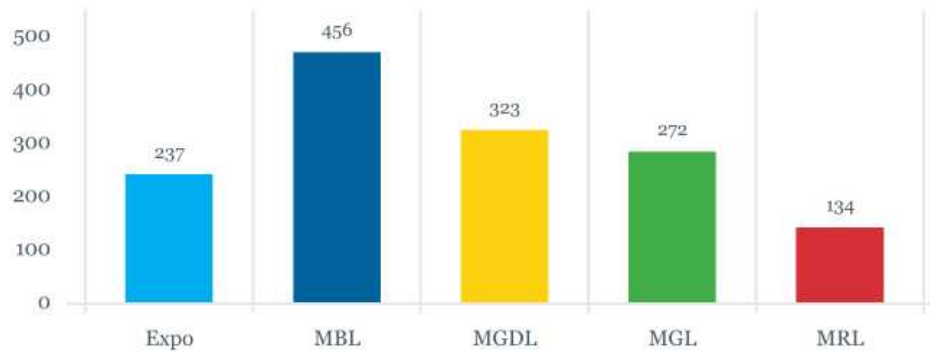
**Figure 6: Rail Vehicle Incidents by Line**

Based on the information from the ROC, a total of 1,422 rail vehicle incidents were recorded for 2016, 1,288 on the four light rail lines and 134 on the subway. (For subways, Metro Purple Line is incorporated into Metro Red Line for this report.) The MBL, which has the largest fleet, had the most rail vehicle incidents. (see figure 6.)
