**File #:** 2019-0232, **File Type:** Informational Report

### OPERATIONS, SAFETY, AND CUSTOMER EXPERIENCE COMMITTEE MAY 16, 2019

**SUBJECT: OFFICE OF THE INSPECTOR GENERAL REPORT ON BUS OPERATOR SAFETY  
BARRIER USE AND EFFECTIVENESS STUDY**

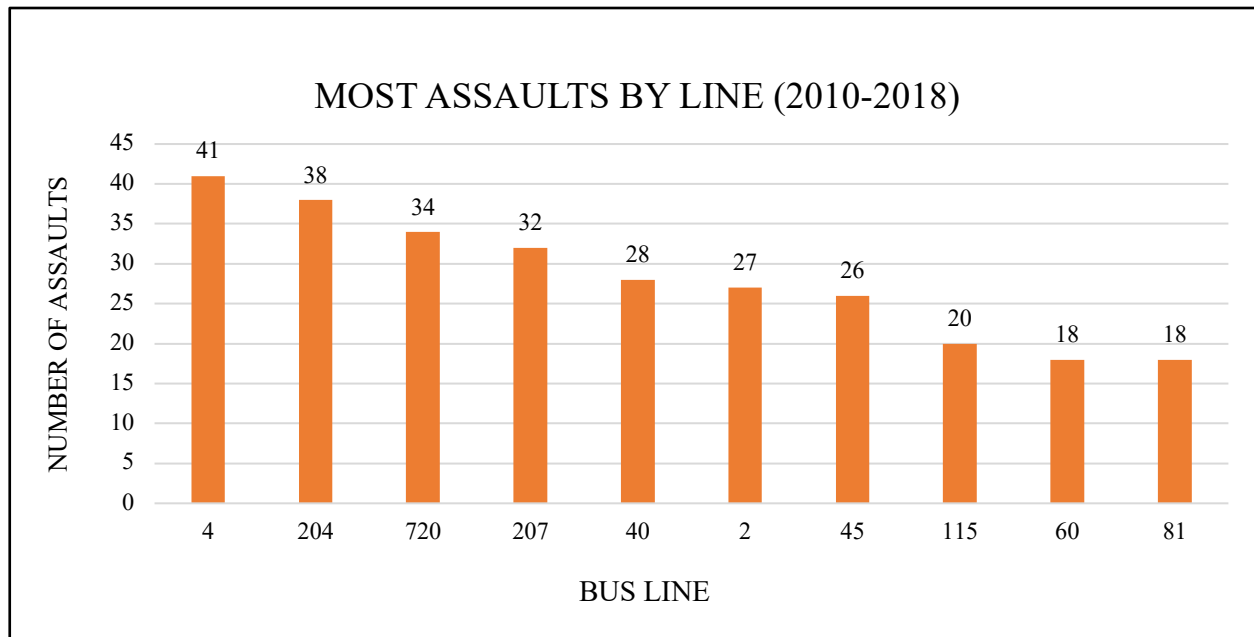
**Figure 3.0.5**

A further breakdown of assaults by bus line is illustrated in **Figure 3.0.5**. From 2010-2018, the top five lines with the most assaults were lines 4, 204, 720, 207, and 40. The graph shows the top ten lines with the most assaults to provide a more detailed analysis across multiple lines.

Bus routes 4, 204, 720, 207, and 40 were identified as the top five routes having the most frequent occurrences of assaults on bus operators. Assaults on bus operators occur most frequently between 13:00 and 17:00 hours (i.e., 1:00 pm to 5:00 pm). Fare disputes are the most frequent cause of assaults on bus operators.

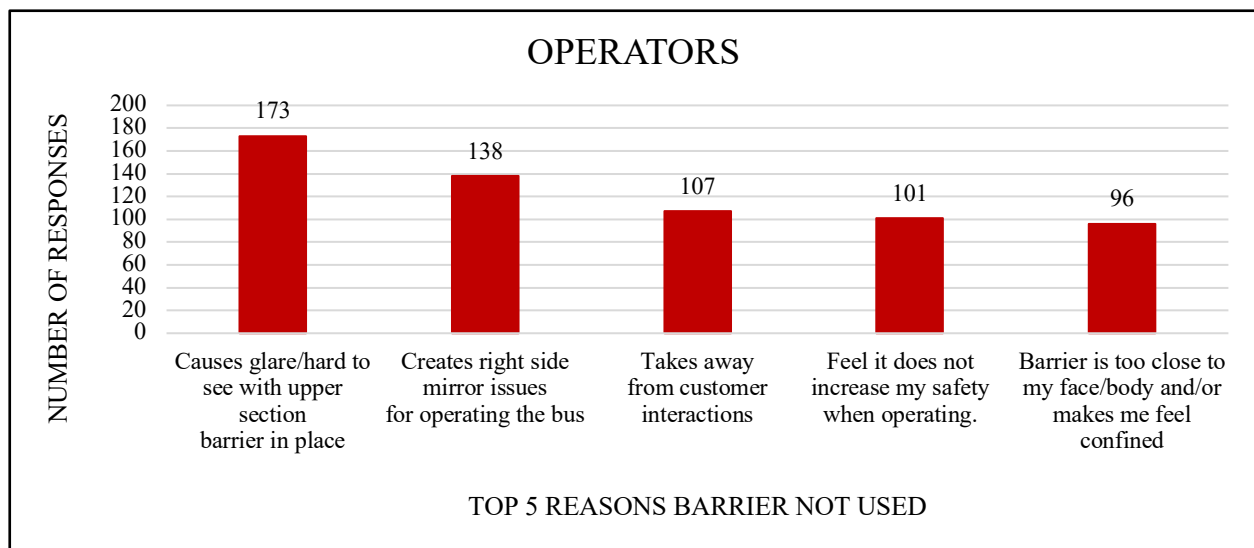
**Figure 4.0.3**

In addition, although the survey responses indicate a high number of operators are using the safety barriers, a significant number (251 or 75%) of responses received stated reasons why the barriers were **not** used. This indicates that while many bus operators have used the barrier systems, they are not used consistently.
