Los Angeles County Metropolitan Transportation Authority
One Gateway Plaza
3rd Floor Board Room

Agenda - Final

System Safety, Security and Operations Committee

LA Metro Safety Culture and Rail Operational Safety Review

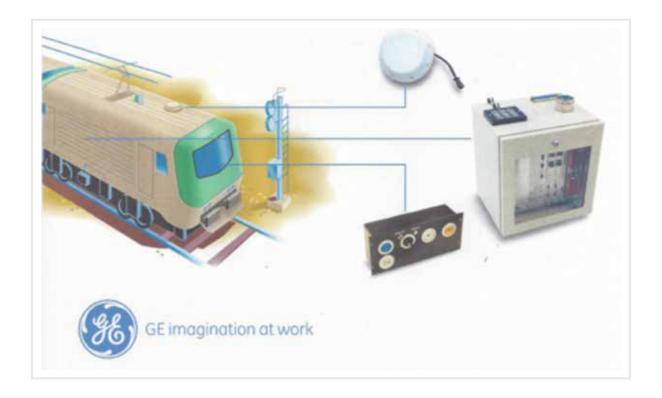
A second technological approach that is also challenging to implement is to employ microwave to transmit the status of an interlocking signal to an approaching train. This SSC-ATP system from General Electric does not require devices or cables mounted in the track area. Its wayside components are mounted on the track, deriving their power from the existing signals, eliminating the need for new power cables. The system uses microwave technology to transmit signal and track information to the train. Onboard equipment is used to provide a wide range of applications from simple warning devices that the interlocking signal ahead is displaying a "stop" aspect, to an enforcement of the signal aspect.

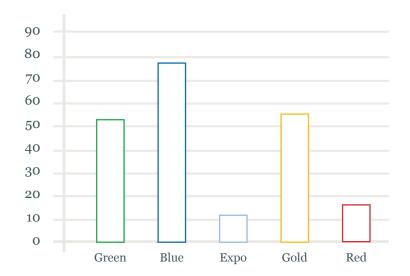
The following chart shows the distribution of signal failures for the various Metro lines:

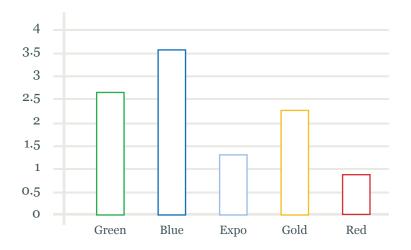
The following graph shows a failure per track mile distribution:

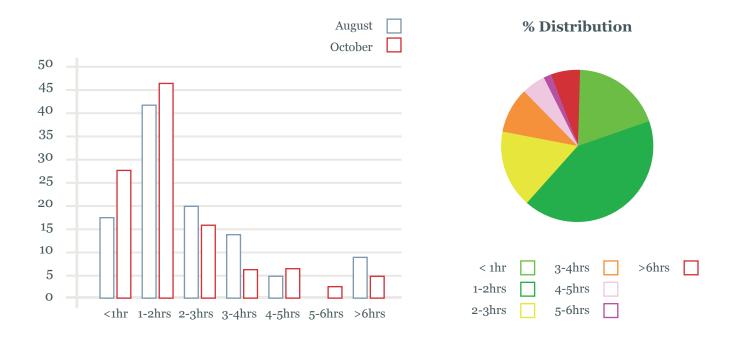
This data is shown on the following graphs:

The above TTR distribution shows that approximately 78% of all signal failures are repaired within 3 hours, including travel time. It is difficult to compare TTRs for various transit properties as many parameters affecting TTR vary from property to property. Metro has not provided TWG with performance metrics related to signal maintenance efforts.

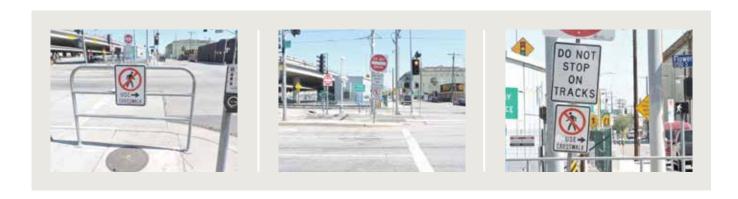
There are a number of pedestrian and vehicle signs that are missing at this intersection. They include:

- Advance warning signs
- · Look signs
- No vehicle on track sign
- Suicide crisis line sign

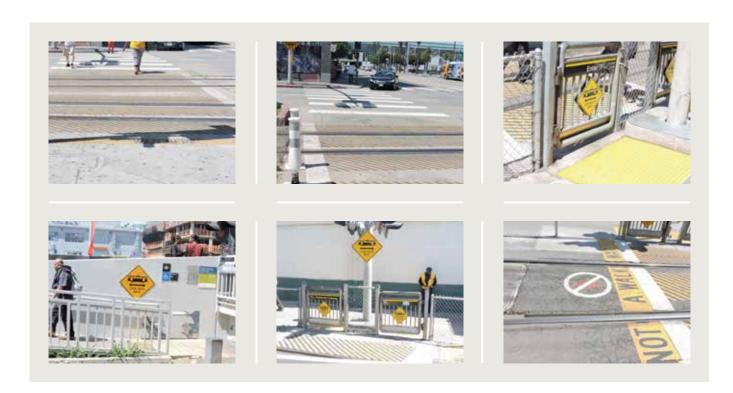
Street Markings

This intersection has good street makings to guide pedestrians through the crossing. Contrasting pavement color is provided to designate track areas. Pico Station also has pedestrian channelization with a barrier installed to guide pedestrians exiting from the station.

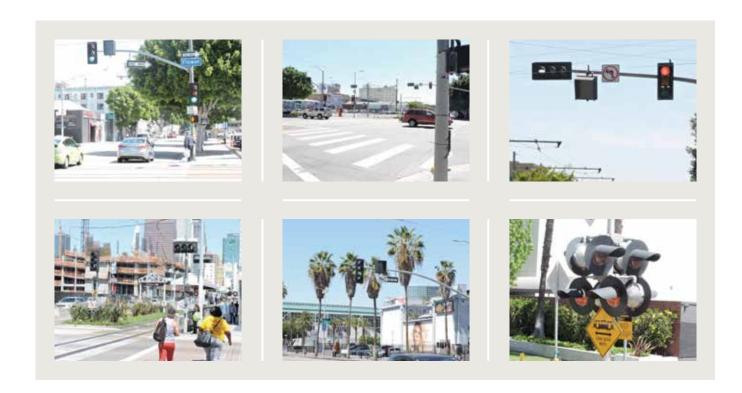
Traffic Equipment

Traffic signals are provided at the intersection to control the movements of vehicles, trains and pedestrians. A multi-phased traffic controller controls traffic signal aspects as well as the bar signals for trains. Pedestrian signals are activated manually via push buttons. Pedestrian flashing warning lights and bells are installed at Pico Station.

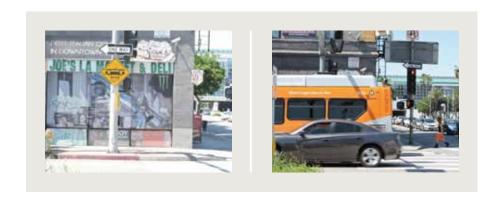
One of the "Look" signs is installed at a bus stop. When a bus makes a station stop, the sign is not visible.

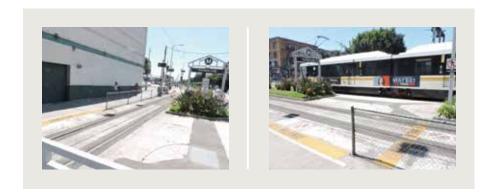
An unprotected private driveway exists at the south end of Pico Station. Based on the accident records provided by Metro, 12 accidents including one fatality occurred at driveways along Flower Street. The issue of unprotected private driveways was brought to the attention of Metro's Corporate Safety to ascertain if Metro took actions to mitigate the risks associated with these driveways.

Corporate Safety indicated that it has taken a number of measures to address the risks associated with private driveways, and advised TWG of the following:

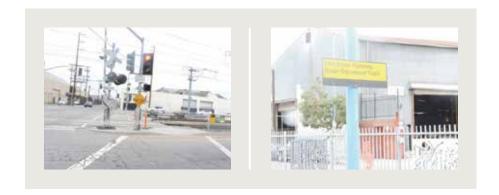
This intersection includes most of the basic vehicle and pedestrian signs, with the exception of the "No Vehicle on Track" sign and "Do not Stop on Track" sign.

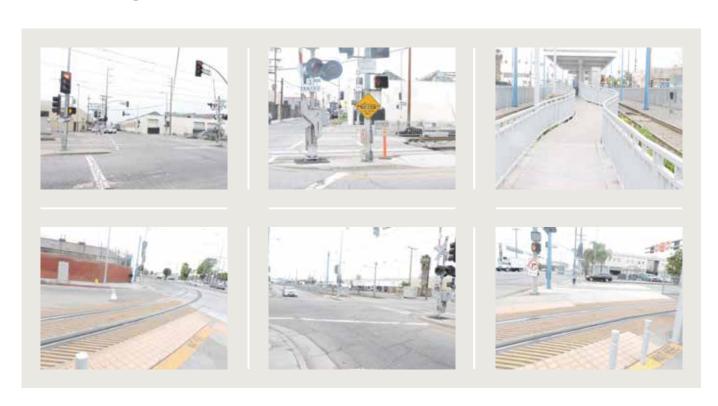
Street Markings

The 20th Street intersection (south end of Washington Station) does not have street markings or channelization to guide pedestrians through the crossing. Further, there is no street marking or treatment to mark the edge of the crossing. However, the north end of the station has channelization to guide pedestrians to exit the station. Further, street markings north of the station employ contrasting pavement color or texture for pedestrian crossings.

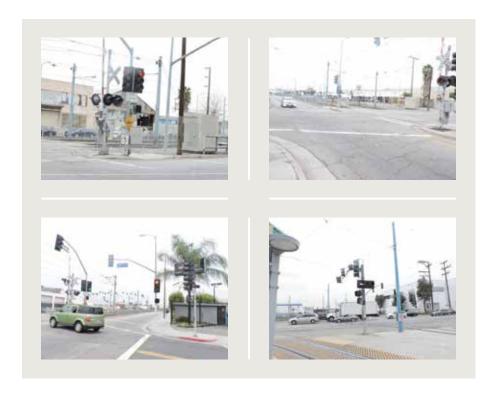
The 20th Street intersection is equipped with basic crossing gates, flashing lights and bells for vehicles. There are no pedestrian flashing lights, gates or bells at this intersection. The only pedestrian crossing lights at this intersection are countdown lights that are manually activated by pedestrians.

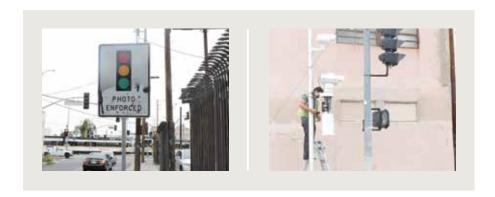
Photo enforcement is provided for traffic signals at the south end of Washington Station.

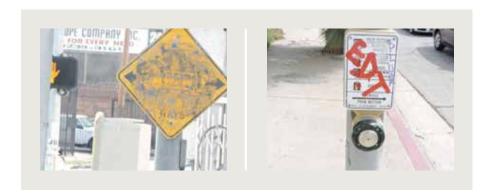
Further, a number of signs at this intersection are covered with graffiti.

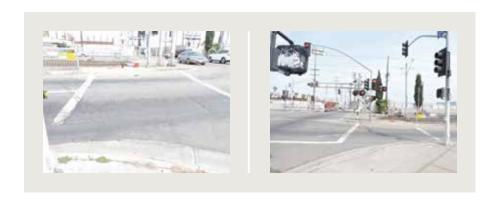
There are no street markings or channelization to guide pedestrians through the crossing. Further, there is no street markings or treatment to mark the edge of the crossing.

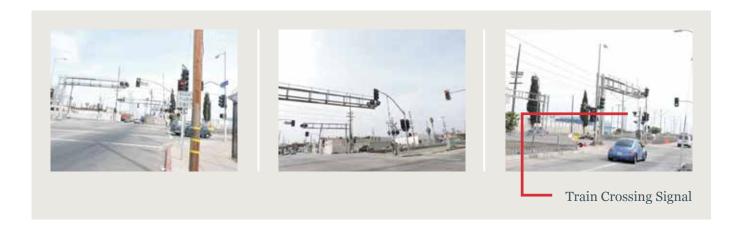
This intersection is equipped with basic crossing gates, flashing lights and bells for vehicles. There are no pedestrian flashing lights, gates or bells at this intersection. The only pedestrian crossing lights at this intersection are countdown lights that are manually activated by pedestrians.

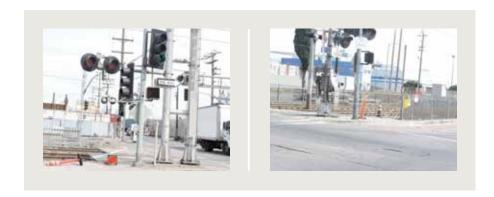
During our site visit at this location, we observed that the temporary identifier used to identify priority signal locations is placed on the right of way in an attempt to create a pedestrian barrier. It is not a good practice to use this temporary identifier in a different application that is not associated with a priority signal location. Such practice dilutes the safety intent of this temporary identifier.

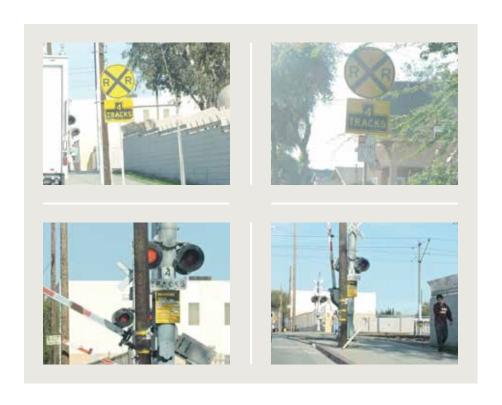
There are a number of pedestrian and vehicle signs that are not provided at this intersection. These include:

- Look signs,
- · No vehicle on track sign,
- Emergency notification sign,
- · No pedestrian sign, and
- "Stop here when flashing" sign.

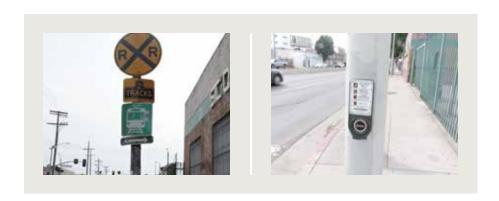
There are a number of pedestrian and vehicle signs that are not provided at this intersection. They include:

- Look sign,
- No vehicle on track sign,
- Stop here on red sign,
- "Suicide Crisis Line" sign,
- · No pedestrian sign, and
- "Stop here when flashing" sign.

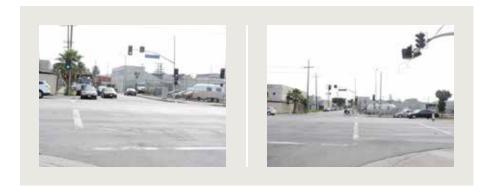
There are no street markings or channelization to guide pedestrians to cross the tracks, and pedestrian street markings are fading and need to be repainted.

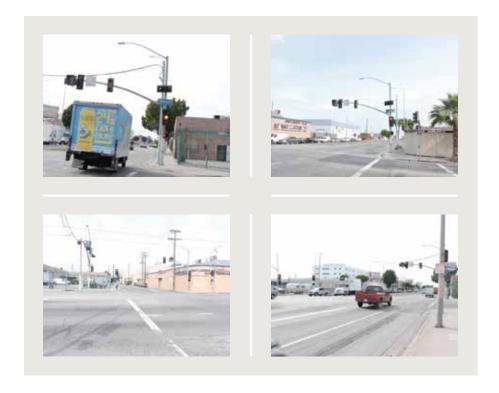
Traffic signals are provided at the intersection to control the movements of vehicles, trains and pedestrians. A multi-phased traffic controller controls traffic signal aspects as well as the bar signals for trains. Pedestrian signals are activated manually via push buttons.

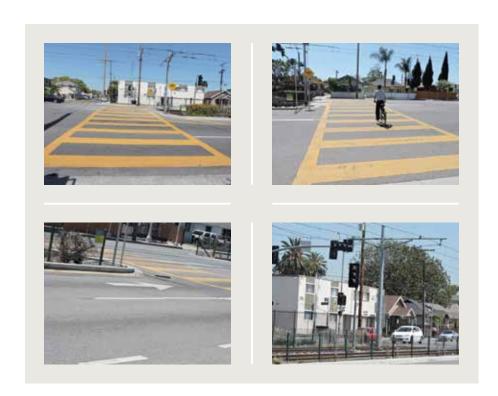
The street markings for pedestrians and vehicles at this intersection provide basic guidance for pedestrians to cross the tracks, and are in fair condition.

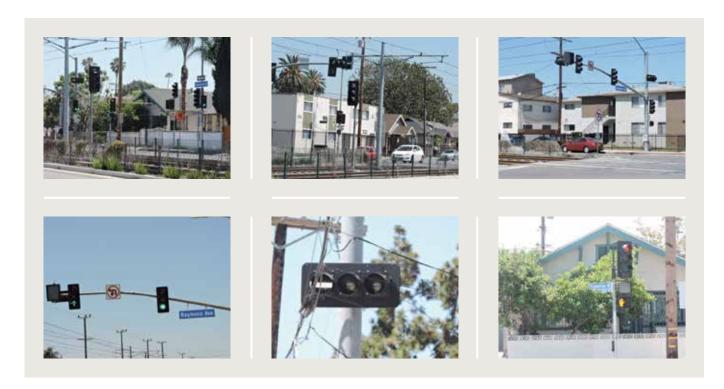
Traffic signals are provided at the intersection to control the movements of vehicles, trains and pedestrians. A multi-phased traffic controller controls traffic signal aspects as well as the bar signals for trains. Pedestrian signals are activated manually via push buttons.

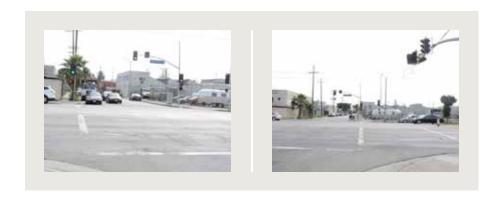
Traffic signals at this intersection are photo enforced.

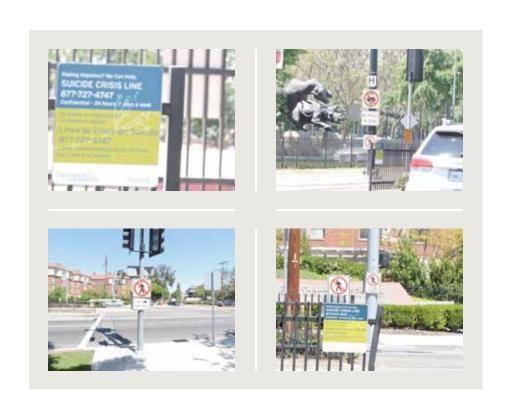
There are a number of pedestrian and vehicle signs that are missing at this intersection. They include:

- · Advance warning signs, and
- · Look signs.

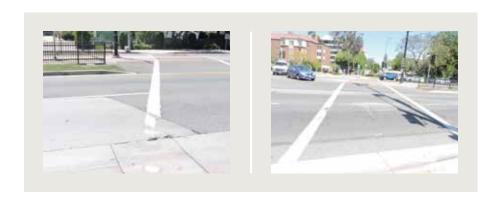
There are only fading white lines to mark the pedestrian crossing. There is no channelization to guide pedestrians through the crossing.

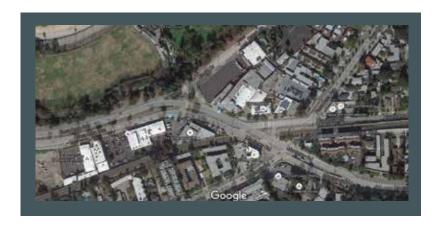
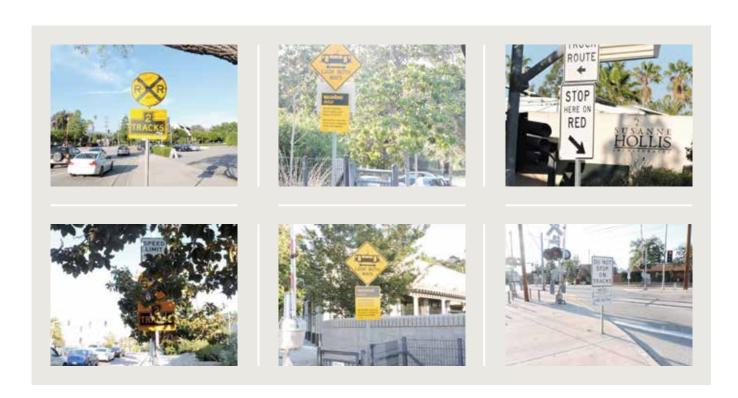
Signage

The intersection of Pasadena & Monterey Road is located within the dedicated right-of-way on the Gold Line. Records provided by Metro indicate that two train/pedestrian accidents occurred at this intersection between 2013 and 2014, resulting in one injury and one fatality.

The two prior accidents at this intersection are attributed to trespassing by pedestrians. As such, the main contributing factor to the accidents is unsafe behavior on the part of the public.

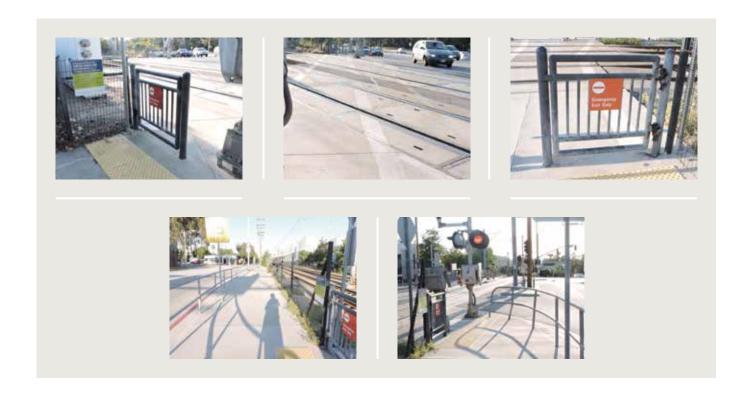
Adequate crossing protection is provided to pedestrians, including channelization to guide pedestrians through the crossing and swing gates. However, street markings within the intersection are fading away.

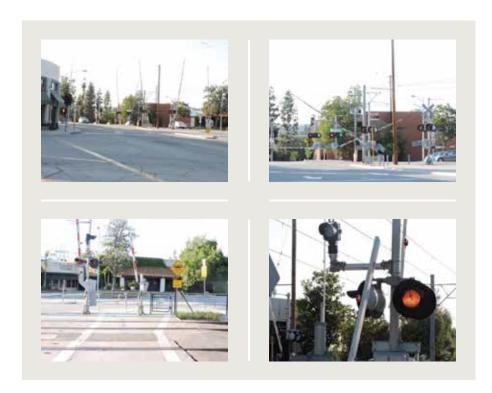
This intersection is equipped with a Four-Quadrant gate system, including crossing gates, flashing lights and bells for vehicles. Pedestrian flashing lights, gates and bells are also provided.

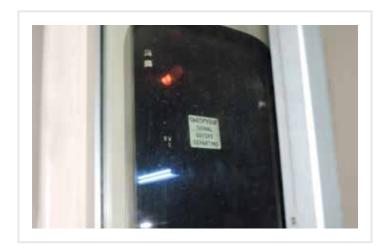
• When the train operator's cab is aligned with the motorman pushbutton location, Signal 8 is not visible from the train operator's position. The train operator needs to lean to the right side of the cab to see the signal.

Based on the above, it is believed that the following factors may contribute to red signal violations at signal 8:

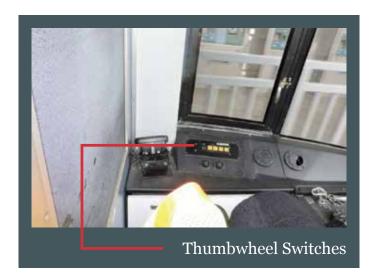
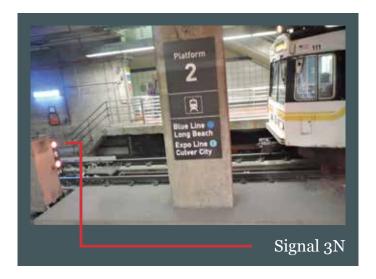
- The TO SOP instructs Train Operators to select a destination route at signals 1S & 2S, by entering a code on the cab thumbwheel. The TWC code will be transmitted to wayside signal equipment to establish the appropriate route at the Flower/Washington Junction.

• The TO SOPs indicate that there are differences in the mechanism to update the destination sign between P-865 vehicle and the P-2000 vehicle.

• The TO SOPs note that moves into occupied platform or tail track are prohibited without ROC authorization.

- This division of responsibility between controllers and train operators, and the different modes used to establish a route at signal 3N, could result in false expectation by train operators that an interlocking signal would clear. It should be noted that this site specific operational condition supports the General APTA Peer Review finding that "Train operators operate with the assumption that a signal would be clear or would change to a clear position".

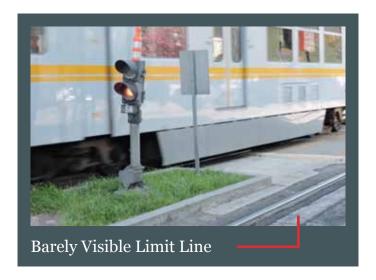
The Stop Signal Working Group identified the following issues at Signal 5N:

- The bar signal at the intersection changes very quickly,
- The Limit Line at the signal location is barely visible, and
- The signal remains "Green" until the train crosses the intersection.

While the Limit Line should be repainted, a violation of the limit line by itself does not register as a red signal violation because the controlling track circuit is located at least 50 feet north of the signal location. However, if the train stops past the limit line, then it will be difficult for train operator to see signal 5N. Upon the clearing of the bar signal at the intersection, and the movement of the train past the intersection, a red signal violation will register when the train passes the insulated joint for track circuit 15T.

With respect to a fast changing bar signal, this will not contribute to a violation. However, a clear bar signal at the intersection can distract train operators from paying attention to signal 5N. It should be noted that the APTA Peer Review Panel identified lack of coordination between bar signals and interlocking signals at an intersection a one of the contributing factors to violations.

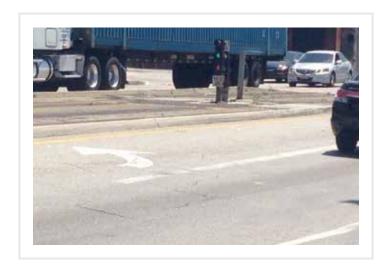
The Maple Avenue interlocking is located between San Pedro and Grand Stations within the Street Running territory. The ROC Controller SOPs indicate that Maple interlocking does not have an automatic mode, and that signal 2S should remain fleeted during normal operation.

- 1. Signal 2S is located between Hill and Maple Streets, and is clearly visible from the operator's cab. A number of bar signals are located in the approach to, and ahead of signal 2S.
- 2. Reverse running signals 2N & 4S are installed on the right side of the track.

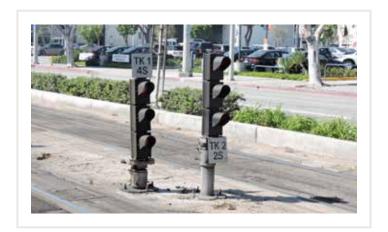
- Southbound routes (signals 2S & 4S) for trains originating at 7th & Metro are established based on the TWC code that was imputed by train operators via thumbwheels,
- Northbound routes (signals 2N, 4N, 6N & 8N) are established based on "first come, first serve",
- Signals are called when trains are in the approach, and
- A "Check Route" sign is provided in the approach to signals 2S and 4S to remind train operators to ensure that the proper route at these signals is established.

The site visit revealed that signals 2S and 4S have good visibility. However, these southbound signals are installed side-by-side, which is contradictory to basic training provided to train operators.

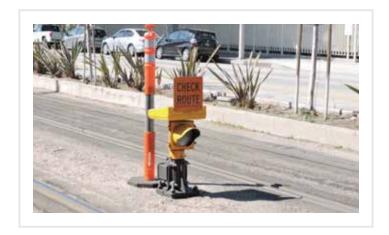
Similar operating conditions exist at northbound signals 2N & 4N: good visibility however, the signals are installed side-by-side.

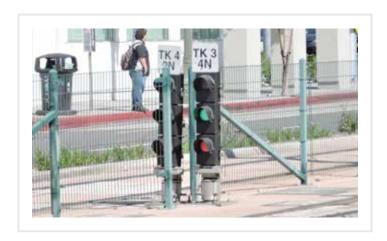
With respect to northbound signal 8N, it is partially obstructed by automatic vending machines installed at the north end of Grand/LATTC Station.

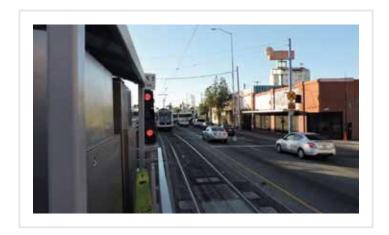
The Stop Signal Working Group identified two main issues at Washington & Flower Junction:

- There are issues that could result in misrouting of trains at Signal 2S, and
- Signals installed on the right side of the track contradict with what was taught to train operators,

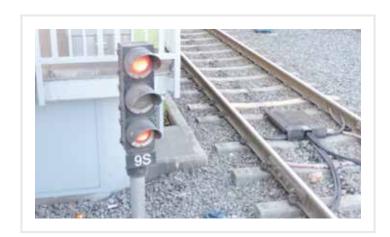
• Signal 9S is installed at the entrance to the station. Its function is to control the movement of a train into the station. It normally displays a FG/R (Flashing Green over Red) if there is no train at the platform. If a train is berthed at the platform, signal 9S displays R/R (Rule 3082). Also, this signal is located at the boundary between street running and ATP (cab-signaling) territory. There is a sharp curve in the approach to the signal, which results in a short sighting distance for the signal. Further, there is no enforcement at this signal, and safety of operation depends entirely on compliance with operating rules and procedures.

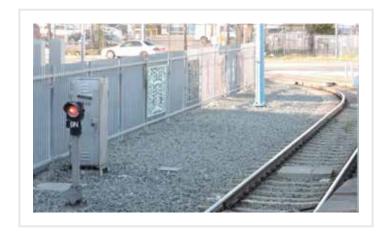
• Signal 9N is a reverse running signal located at the entrance to street running territory. It normally displays a "Red" aspect, and requires authorization from the ROC to proceed (Rule 3082). This signal is at the approach to a sharp curve.

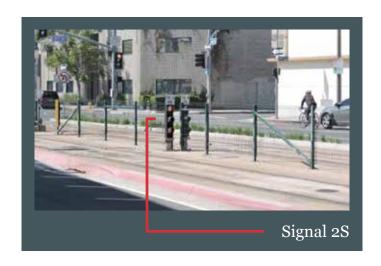
With respect to the operational characteristics at 22nd Street interlocking, this location is similar to other interlocking locations within street running territory.

The normal and reverse running signals 2S & 4S are installed side-by-side, and are located in the approach to the 21st Street intersection. A traffic Bar Signal is located at the far right corner of the intersection, and operates independently of the interlocking signals. The ROC Controller SOPs indicate that this interlocking does not have an "Automatic" mode and that during normal operation, the interlocking remains in "Central" mode with signals 2S and 4N fleeted.

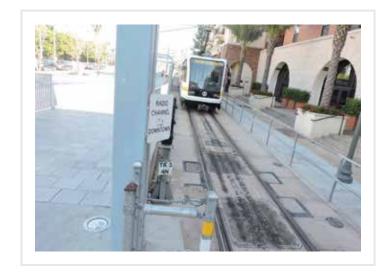
- Reverse running signal 4S is installed on the right side of the track,
- There is a slight curve in the approach to signal 2S, and
- A "radio" sign is partially obstructing signal 4N at the north end of the station.

The Stop Signal Working Group did identify the curve in the approach to Signal 2S as a potential contributor to red signal violation. It was indicated that it is difficult to see the signal from 500 feet. However, the signal representative indicated that there is a restricted speed approaching the station, and train operators should be slowing down.

As indicated above, one of the three violations at Signal 2S was attributed to ROC error, and the remaining two violations to "Operator Inattention". However, one of these two violations involved a landscaper on the right of way, which could have distracted the train operator. Other factors that could contribute to violations at this location include:

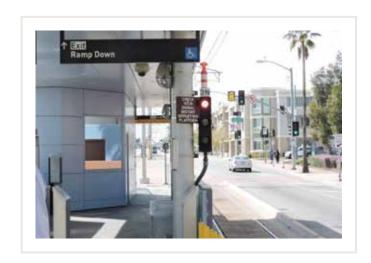
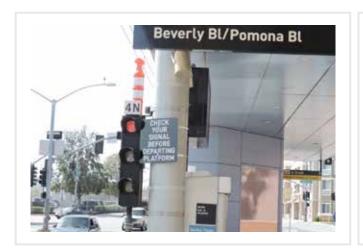
- Reverse running signal 2S is installed on the right side of the track,
- Good visibility for signals 2N & 4N, and
- Good visibility for signals 2S & 4S.

The Stop Signal Working Group made a number of observations related to the angle/orientation at the various signals. Further, the group questioned if the 500 feet sighting distance requirement is satisfied at signals 2S & 4S.

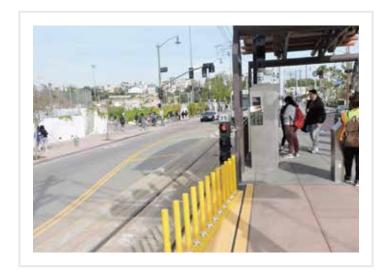
With respect to the operational characteristics at Pico Aliso Station, this location has similarities to other interlocking locations within street running territory. The normal and reverse running signals 2N & 4N are installed side-by-side in the interlocking and past Gless Street intersection. Based on description in

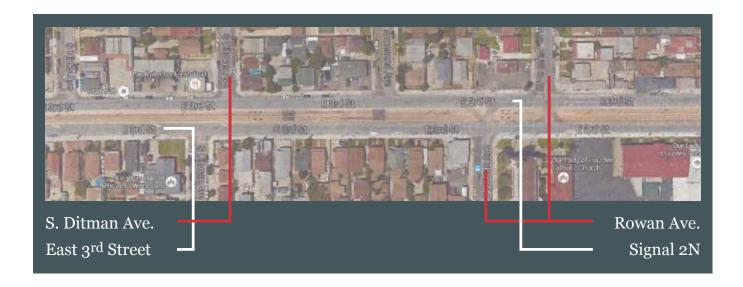
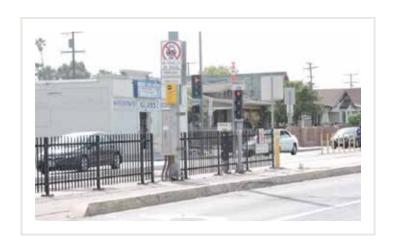
With respect to the operational characteristics at Ditman Interlocking, this location has similarities to other interlocking locations within street running territory. The normal and reverse running signals 2N & 4N are installed side-by-side. Based on description in the ROC Controller SOPs, Signals 2S, 4S, 2N and 4N have approach clearing if the interlocking is operating under "Automatic" mode. However, a review of the incident reports does not reveal the mode of operation in effect at the time of the violation incidents.

Signal 2N, where all the violations occurred, is located between two street intersections with Rowan Ave. There is a first Bar Signal (#1) located at the left side of the track in the approach to signal 2N, and a second Bar Signal (#2) located at the right side of the track in front of Signal 2N. Similar to other locations, interlocking signal 2N and the Bar Signals operate independent of each other.
